## INVESTIGATION OF THE STRESS-STRAIN STATE OF BUILDING STRUCTURES DAMAGED BY EMERGENCY SITUATION

**Abstract.** The article investigates the stress-strain state of building structures damaged due to an emergency situation resulting from a missile strike on a building in Odesa. The study aimed to comprehensively analyze the technical condition of the damaged structure, evaluate the impact of the missile strike on bearing capacity and deformation behavior, and provide recommendations for restoration. The authors conducted detailed instrumental inspections utilizing non-destructive testing techniques, performed topographic and geodetic surveys to determine structural verticality, and carried out verification analyses using the "LIRA-SAPR" software. Significant damages to columns, floor slabs, and external walls were identified, creating a risk of progressive structural collapse. The structures were classified as being in an emergency state, with damage levels reaching up to 80%. The proposed restoration measures involve dismantling and reconstruction of damaged elements, reinforcement of load-bearing structures using metallic components, installation of temporary support systems, and

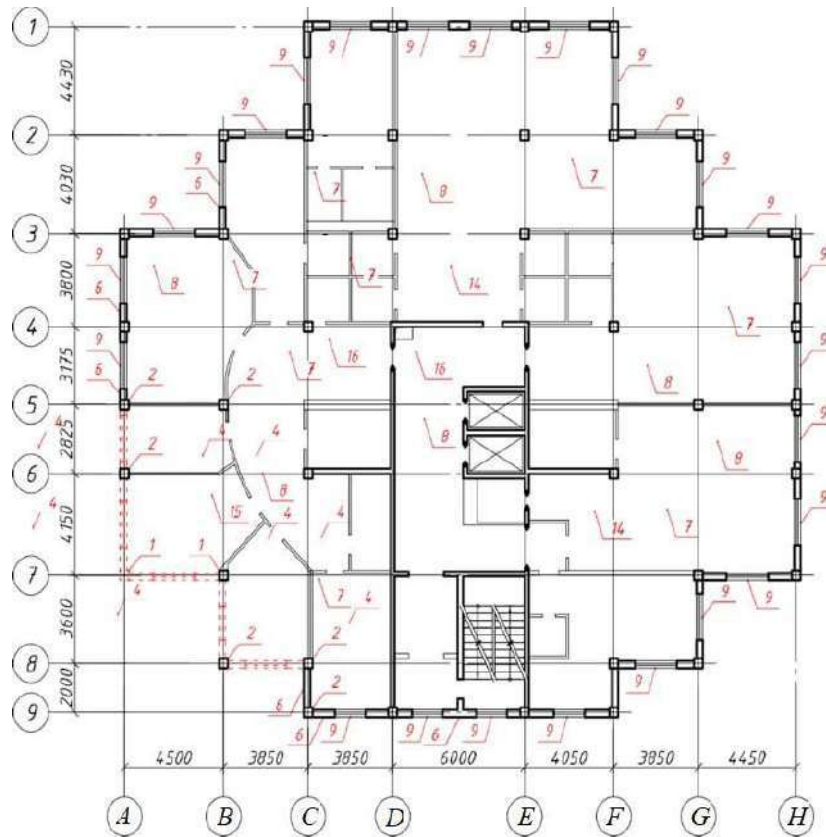
Fig. 2. Diagram of damage location. 8th floor

3. The external self-supporting walls in axes "A-B, 5-7" at the level of the 8th and 9th floors are destroyed (Fig. 2-5), the degree and nature of existing damages in the adjacent walls indicate the danger of emergency collapse.

1. Significant damage to columns. Perform dismantling and restoration.

2. Damage to columns. Perform reinforcement.

3. Significant damage to floor structures. Perform partial dismantling and restoration.

4. Technological damages (equipment passage holes, exposure, and damage of working reinforcement), cracks.

6. Significant damage to external walls. Perform dismantling and restoration.

7. Significant damage to partitions. Perform dismantling and restoration.

8. Significant damage to ceiling finishes. Perform dismantling and restoration.

9. Significant damage to openings infill (windows, doors). Perform dismantling and restoration.

5. Perform reinforcement of columns, diaphragms, and floor slabs at locations of holes and reinforcement damage.

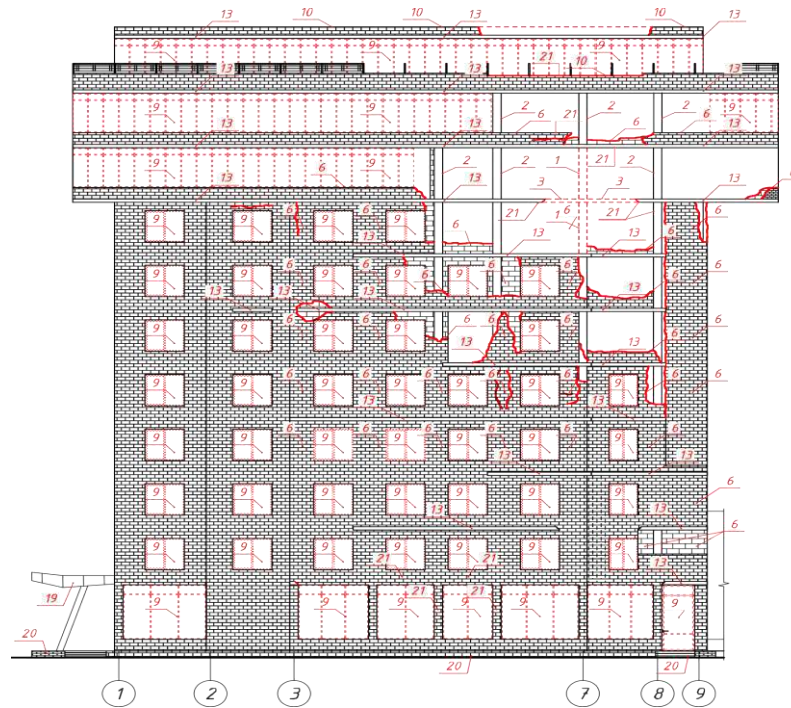
Fig. 4. Damage location scheme. Facade 1-9

10. Damage to brick parapet structures and ventilation channels. Perform partial dismantling and restoration.

11. Roof damage. Perform dismantling and restoration.

12. Roof damage. Perform restoration.

13. Damage to external finishes (brickwork, insulation of floor slabs). Perform dismantling and

restoration.

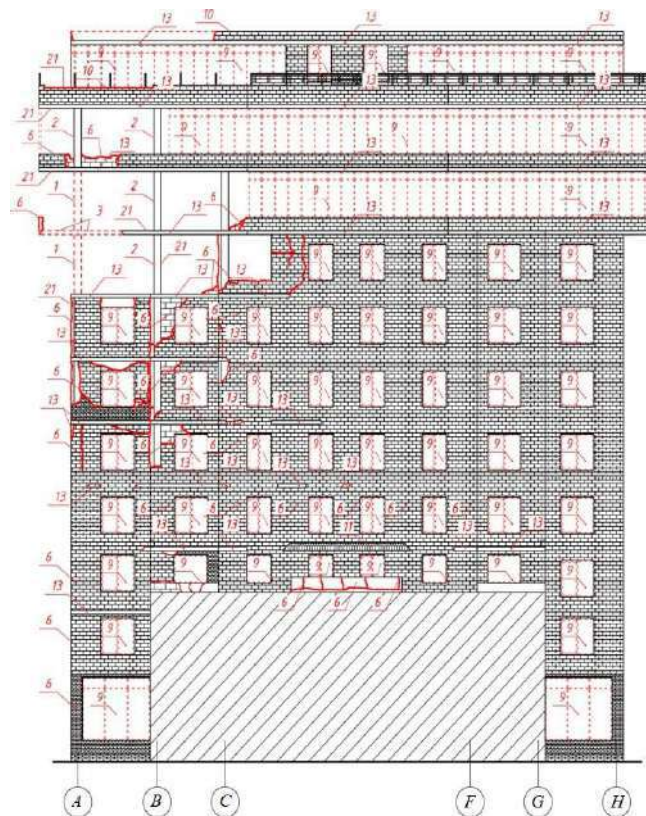
Fig. 5. Diagram of the location of the damage to the A-H facade

1. Significant damage to engineering systems and equipment. Perform dismantling and restoration.
2. Traces of atmospheric precipitation leakage.
3. Emergency area.
4. Corrosion of metal structures.
5. Damage to paving and porches.
6. Traces of fire.

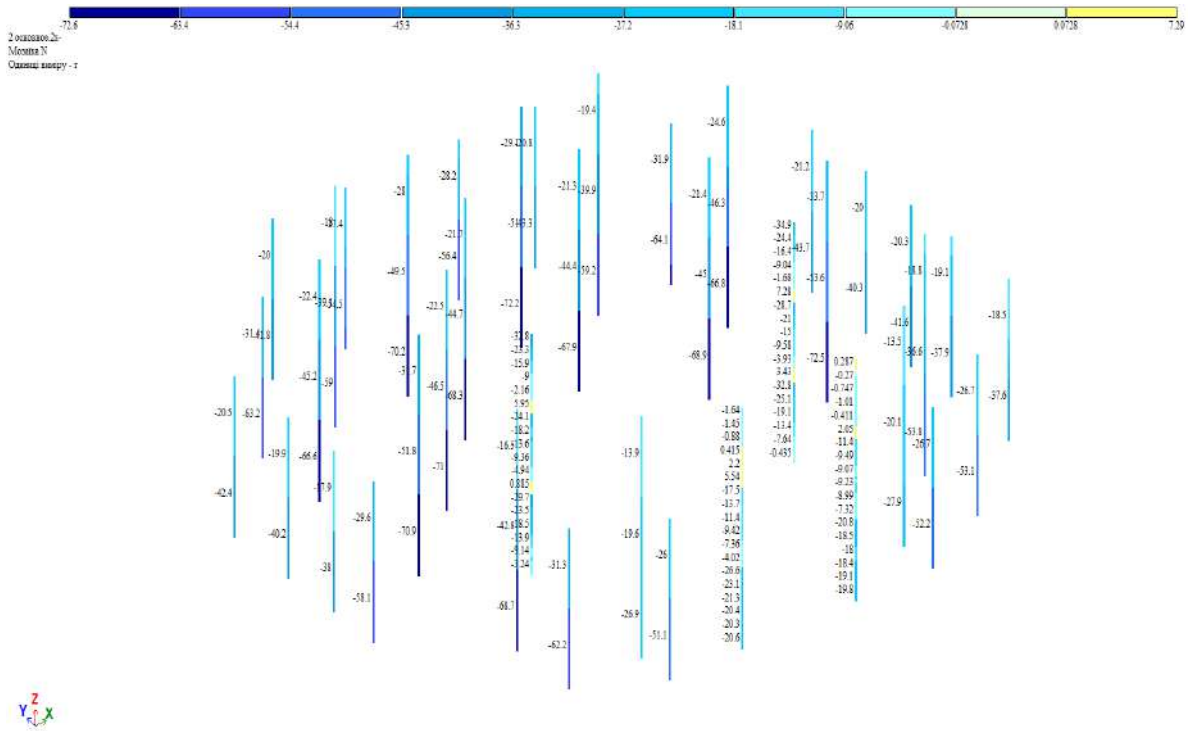
Fig. 12. Mosaic of internal longitudinal forces N. Option №2.

A fragment of the calculation diagram of the building's load-bearing structures with identified and simulated main damage of the load-bearing structures.
