### **BUILDING STRUCTURES**

## THE KNOWLEDGE OBTAINED FROM THE MAIN INSPECTIONS OF PEDESTRIAN BRIDGES IN PREŠOV

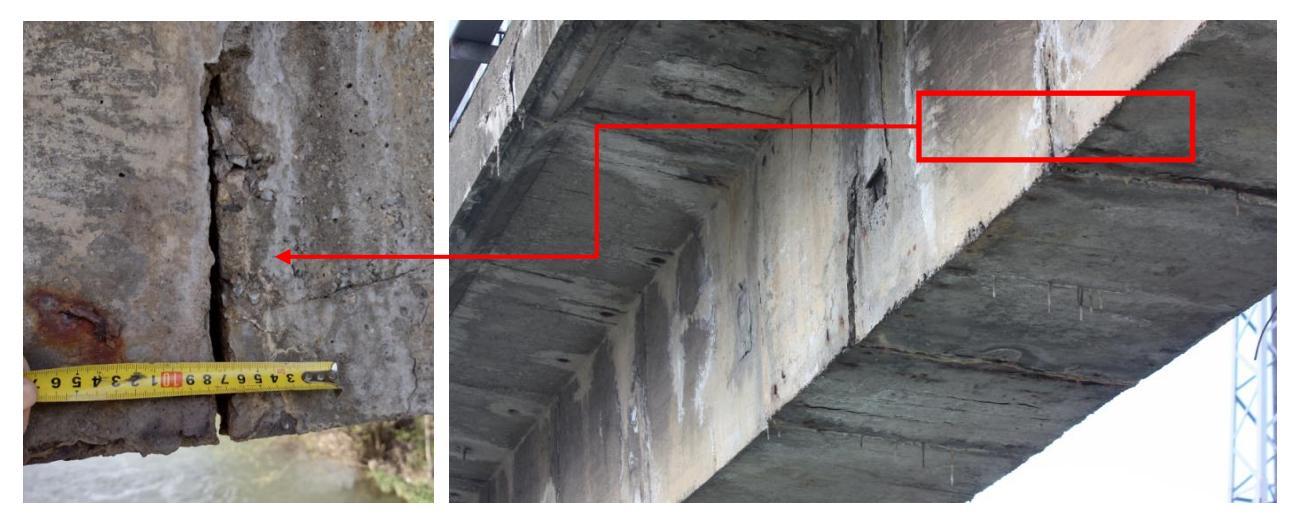
On inspection of the bridge, a significant deflection was visible. This deflection was noticeable on the bottom slab and the bridge's handrail. After a more detailed inspection of the structure, it was discovered that the opening of joints at the contact of beam segments occurred (10 – 15mm) in the middle of the second span. This phenomenon indicates problems with prestressing reinforcement (Fig. 2). After removing the inspection holes in the area of the abutments, it was found that the filling mortar had completely deteriorated due to the very high humidity and freezing cycles.

Fig. 2. Opening of the joints between the segments in the middle of the second span

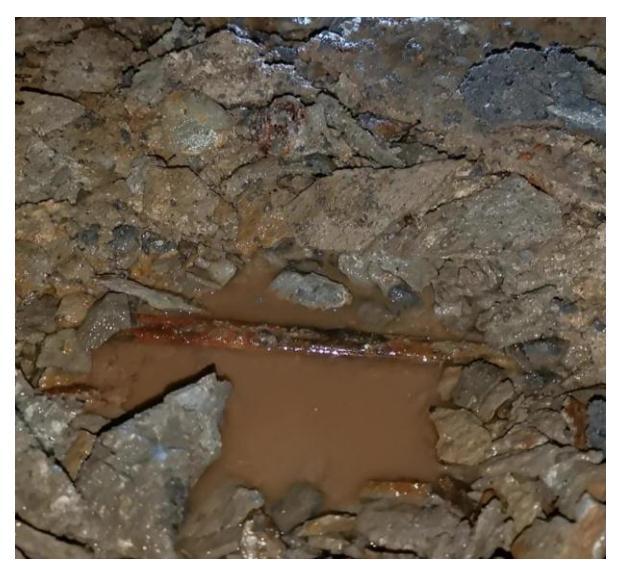
Cementitious mortar, initially protecting prestressed reinforcement, is cracked, carbonated (on-site test on fragments by 1.0% phenolphthalein solution) and does not fulfil its protective function. Water is held in the bridge chamber due to the absent drainage of the chamber. Due to the water, the mortar and the prestressing reinforcement has completely deteriorated in the chamber. Prestressing reinforcement is a critical load-bearing element in this type of structure, and corrosion significantly decreases the bridge's load-bearing capacity (Fig. 3). This state is also supported by noticeable deflection generated by the structure's dead load. The opening of joints between segments accelerates local corrosion of prestressing tendons. Due to the facts mentioned above, the pedestrian bridge was immediately closed to pedestrian traffic.

Fig. 3. Corroded prestressing reinforcement

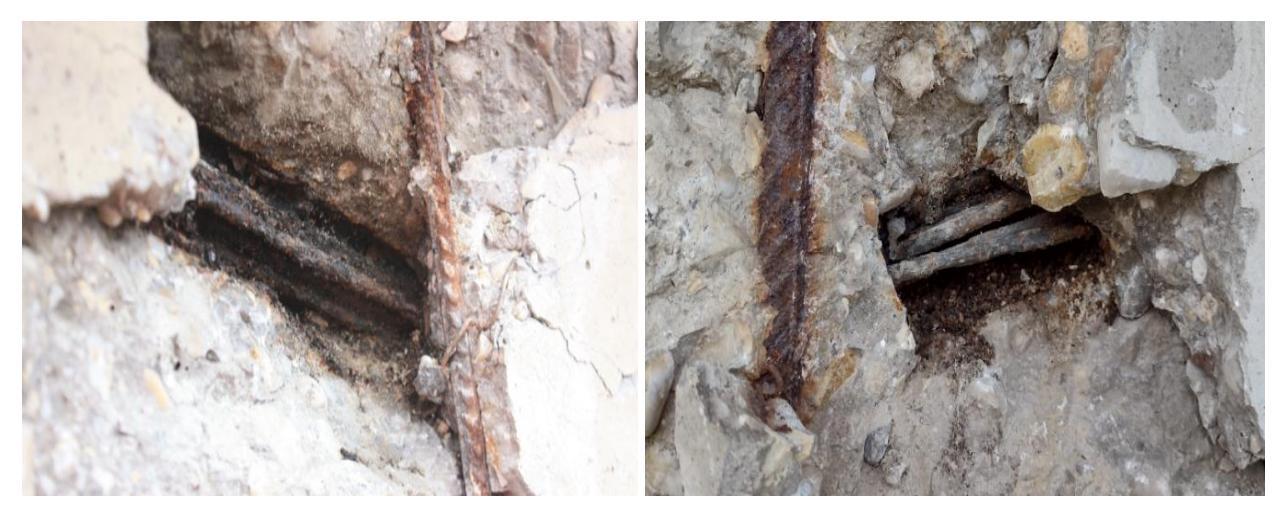
fastened together with prestressing tendons. The length of the beams is 37 m. Their lower and upper flanges are not concreted and thus not connected. Other than lowered cooperation of beams, limited within thin concrete slab constructed above the upper flange, corrosion of stirrups sticking out of beams occurs. These stirrups were to bind a reinforcement of a prefabricated beam with concreting between beams. There are visible cracks parallel to prestressing tendons on the walls of the beams. Non-grouted prestressed reinforcement with advanced corrosion was discovered after removing the delaminating concrete cover layer (Fig. 4). There is a high probability of water leaking into nongrouted ducts, which subsequently freeze in winter. Consequently, the water expands in a narrow duct space and generates cracks parallel to prestressing reinforcement. This phenomenon indicates a problem with the waterproofing of the bridge. The leaking water transports chloride ions from deicing salts along cable ducts.

For both bridges, the permissible chloride levels in the concrete for prestressed structures were exceeded several times according to EN 206 [7]. The permeated chlorides act as a corrosive catalyst, making corrosion progress more rapid due to the lack of diffusive protection around the prestressing tendon. This protection usually consists of a highly alkaline grouting compound. It is assumed that most cable ducts are not grouted or are grouted with poor quality grouting compound, which significantly increases the risk of corrosion of the prestressing reinforcement and thus increases the likelihood of a possible sudden collapse of the structure. Due to advanced corrosion of the exposed prestressing cables, both bridges were immediately closed. They will have to be rebuilt, as they threaten train traffic passing under the bridges.

Fig. 4. Non-grouted cable ducts with corroding prestressing reinforcement

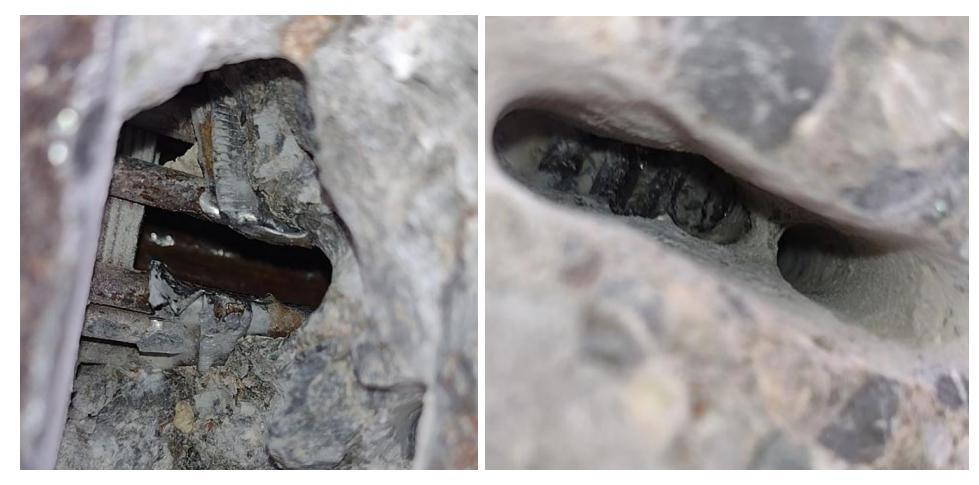
Concrete samples taken from the ledges, under the asphalt and from the bottom slab did not confirm excessive chloride content in the concrete, probably due to the lower intensity of winter maintenance. Prestressing tendons corrode significantly slower, although they are not grouted with cement (Fig. 6). The low chloride contamination of the concrete creates good preconditions for the reconstruction and further functioning of the bridge. The bridge has already been reconstructed and reinforced with free-running external prestressing cables.

Fig. 6. Non-grouted prestressing tendons in the bottom slab of the precast concrete; left – anchorage point, right – approx. 0.5 m behind the anchor
