GEODESIC MONITORING DURING TEMPLE RESTORATION

Odessa State Academy of Civil Engineering and Architecture

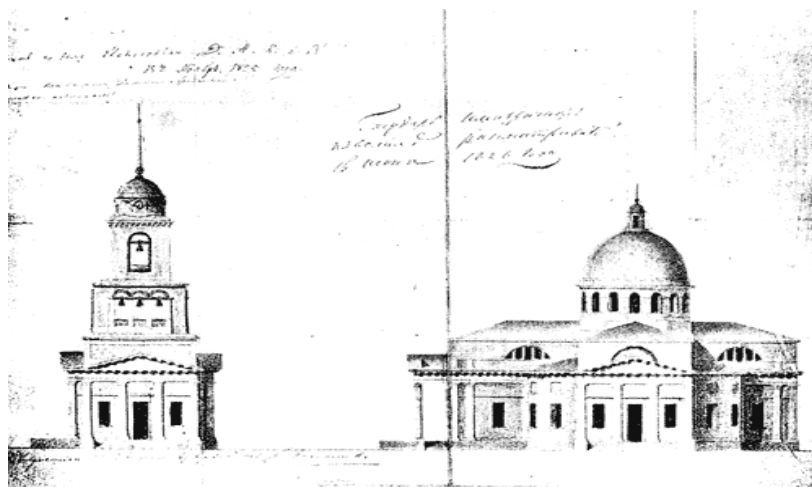
Fig. 3. The project of the 5-level bell-tower of the saviour's Transfiguration Cathedral of made in 1825, the architect is F. M. Shesta

In 1825 (Fig. 2, 3) a project of the bell-tower developed by J. Frapolli was approved. The bell-tower was situated to the west of the Church. Building of the bell-tower was completed in 1837.

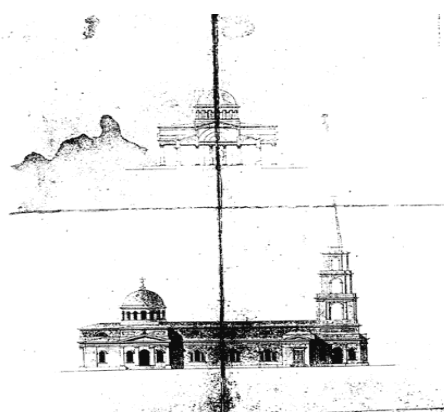
Fig. 5. The project of the front and a sectional arrangement of the refectory of the saviour's Transfiguration Cathedral in 1841

of the Archbishop of Kherson and Tavria Gavriil (Rozanov) in 1841 an architect D. Geidenreich made a project of a refectory, which combined the bell-tower and the old Church (Fig. 4, 5).

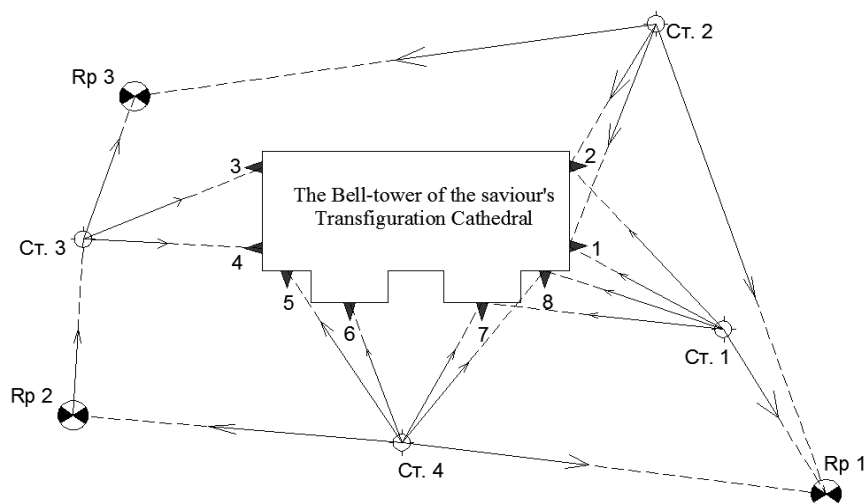
Fig. 13. The diagram of location of lubber lines and stations as related to the bell-tower of the saviour's Transfiguration Cathedral

The observation of the deformational benchmarks was carried out by geometric leveling of the class III (Fig. 13), which is used with vertical moving of the footing base, according to the regulatory documents [4, section 10]:

Leveling of deformational benchmarks was performed from four (St.1, St.2, St.3, St.4) constantly fixed stations. When performing the measurements there was no possibility to control inequality of the shoulders (distance to the rod), therefore the method of «a short ray» was applied – the distance to the rod didn't exceed 25 m, the height of the ray from the ground surface didn't exceed 3 m with fairness distance of the rays from surrounding items more than 0.5 m. The average quadratic deviation of geometric leveling at the station along with intrinsic convergence was 0.3-0.5 mm [1, 5].

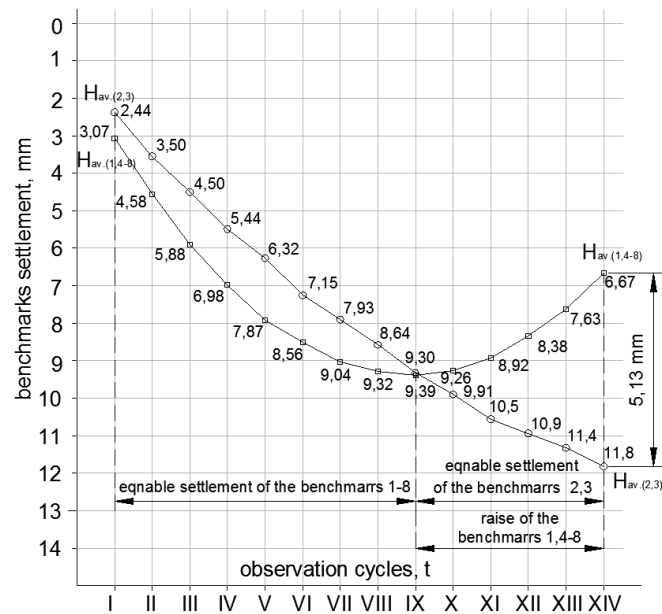
Fig. 14. The assay of experimental and functional dependences $H_{av.(2, 3)}$ та $H_{av.(1, 4-8)}$

From the opposite side of the bell-tower another way of settlement was observed, there were the benchmarks 1, 4-8. From the third cycle to the sixth cycle they gradually settle in average by 0.55 mm, and from a the sixth cycle of the observation to the fourteenth cycle a gradual raising of these deformation benchmarks of the base of the footing in average by 1.27 mm was observed, since a monolithic concrete slab of the bell-tower footing gets an insufficient inclination due to additional loading from the benchmarks 2, 3 during building the main building of the Church (Fig. 14).

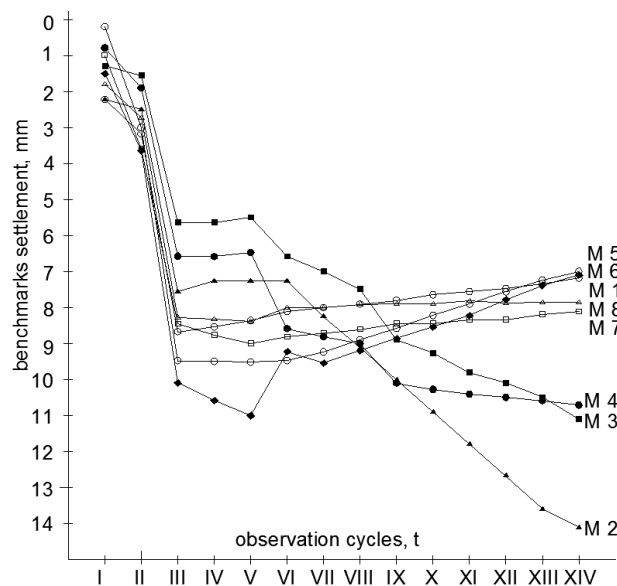
Fig. 15. Settlement progress of eight deformation benchmarks for the period from 9.01.2001 to 10.02.2002

The consecution of the settlement of all deformation benchmarks is presented in the Picture 15, which shows inequality of the settlement. A consistent pattern of the rapid settlement of the

benchmarks 2, 3 in average for the entire period by 7.66 mm with gradual decreasing, and settlement of the benchmarks 1, 4-8 to the contrary – gradually comes to raising.

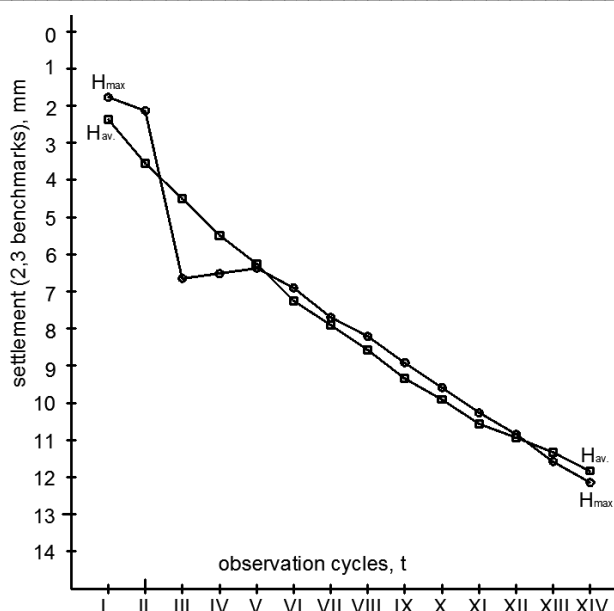
Fig. 16. The graph of experimental and functional dependences of the deformation benchmarks 2, 3

$$H = -0,02826t^2 + 1,14t + 1,33; \quad (2)$$

After forecasting the settlement of the base of the footing of the deformation benchmarks 2, 3 it was obtained that after 20,2 months their average settlement will stop, having reached 12,8 mm.

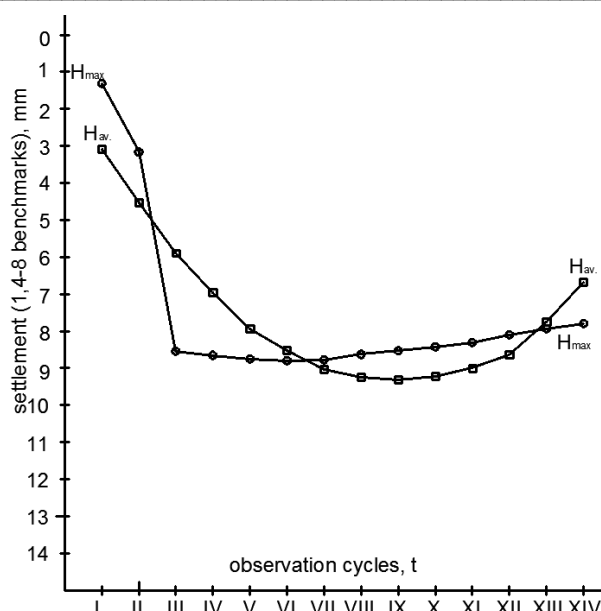
Fig. 17. The graph of the experimental and functional dependences of the benchmarks 1, 4-8

$$H = -0,1027t^2 + 1,817t + 1,352, \quad (3)$$

And average raising of the benchmarks 1, 4-8 stabilized and reached 0,1-0,2 mm.

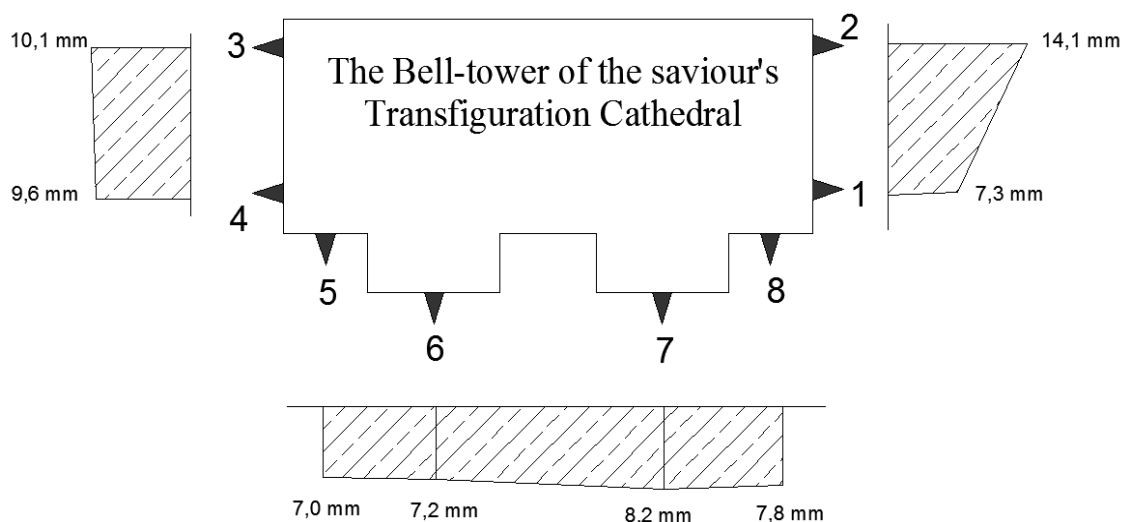
Fig. 18. A diagram of epures of the deformation benchmarks settlement during the entire period of observations, mm

The diagram shows epures of deformation benchmarks settlement as related to the first cycle of the observation (Picture 18). It is visible from this point that maximum settlement of the bell-tower footing is up to 14,1 mm, and minimum is – 7,0 mm [5, 7].
