**ASSESSMENT OF TECHNICAL STATE AND DESIGN OF RECONSTRUCTION  
OF THE SMALL BRIDGE OF THE SLOVINSKY SYSTEM**

**Introduction.** The study focuses on the bridge located in the village of Goshiv, Bolekhiv City Council of Ivano-Frankivsk region at km. 0 + 074 on the Horynia-Bolekhiv public highway which is of local significance. By the structural design, it belongs to a special type of reinforced concrete slab four-hinged bridges with lightweight substructure. This type was introduced in 1948 by M.O. Slovinsky and was named after him: "small reinforced concrete four-hinged bridge with lightweight structure by engineer M.O. Slovinsky system" [13]. The first standard designs of such bridges with spans of 4-6 m were developed by the author together with Ukrdortrans Research Institute and introduced into construction from 1950-1951. The bridge structures were designed for normalized moving temporary loads H-10 and NG 60. Later in 1967, Design Institute "Soyuzdorproekt" developed a standard design for these bridges for augmented normalized vertical moving loads: vehicular H-30 and wheel load NK-80 according to the construction norms SN 200-62. (Technical conditions for the design of railwa

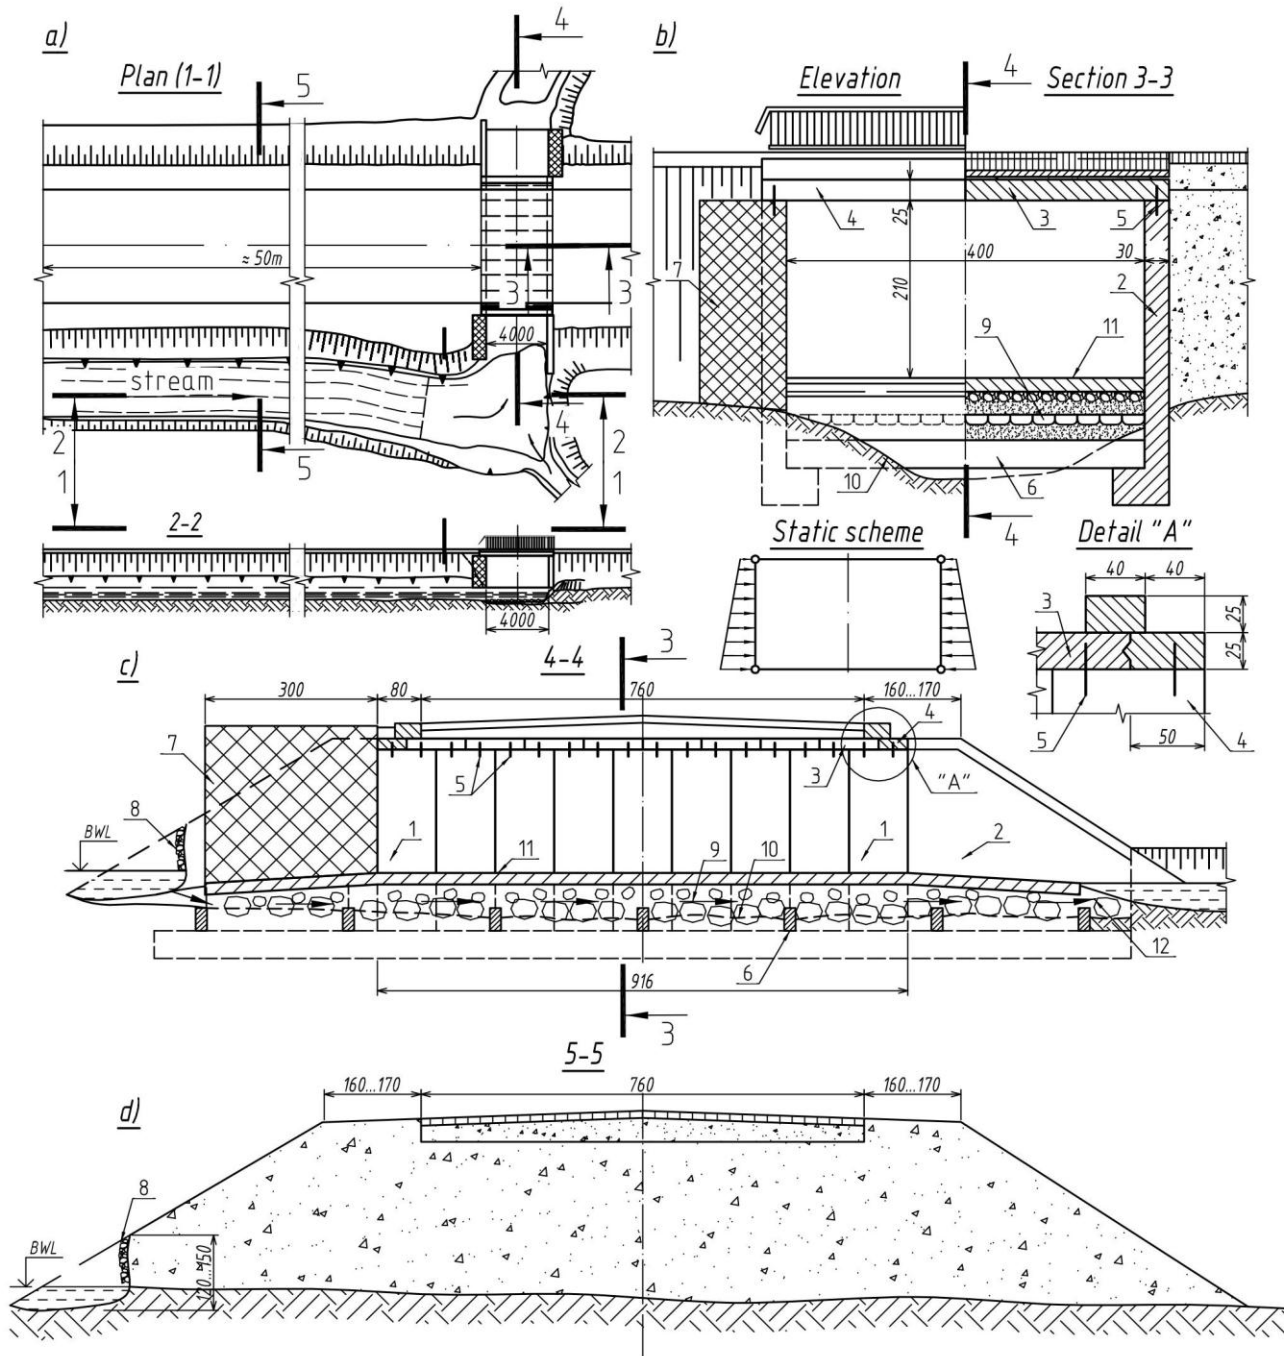
Fig. 2. Situational layout plan (a) and construction of the present bridge (b, c, d):

The prefabricated four-hinged bridge consists of shore buttress piers (stands) with straight sloping wings, connected by a slab span structure. The sustaining walls and the sloping wings form a single unit are made of nine vertically placed reinforced concrete slabs with a nominal width of 100 cm

and a thickness of 30 cm. At the top, anchor pins connect the wall slabs with the span structure slabs. The lower ends of these slabs are either installed in the grooved mortise of the reinforced concrete foundation pad or they are made L-shaped with the foundation resting directly on the ground.

- 1 – prefabricated reinforced concrete blocks of sustaining walls; 2 – prefabricated reinforced concrete blocks of straight sloping wings; 3 – prefabricated reinforced concrete slabs of span structure; 4 – monolithic end slabs of span structure; 5 – connecting anchor pins; 6 – lower struts, hinged to the edge of the foundations; 7 – gabions installed to replace the destroyed sloping wings; 8 – waterworn left bank of the stream and the base of the road embankment slope; 9 – probable design of the stream bed under the bridge, reinforced with masonry (paving); 10 – probable zone of the stream bed erosion under the bridge, opening of stops and their destruction; 11 – re-concreted strut slab, a new bottom of the stream bed above the LWL; 12 – filtration and flow of water at LWL under the strut slab within the altitude of the waterworn old streambed

Layers of pavement to some extent improve the mutual support of slabs and their joint work across the span. However, they cannot replace the monolithic connection of slabs in the longitudinal seams. Therefore, the calculations assumed the articulation of the slabs in the longitudinal seams, thus accepting extensive distribution of the moving vertical load across the bridge. Slab joints of the span structure are located at the junction with the slab joints of the sustaining walls, so anchor pins on top are installed between these joints (Fig. 2, b, c).

Depending on the intensity of the flood, the erosion process can cover the entire section of the channel under the bridge (Fig. 2, b, c). In this case, its initial (design) attachment 9 will be destroyed and the erosion zone 10 will reach the lower underground struts 6. They will be unearthed and may be damaged or even destroyed by the flow and solid component of water-borne material (river runoff). If the struts 6 freely rest on the edges of the foundations (hinged support), they can be easily knocked out of their position by a strong stream of water. This will inevitably lead to the destruction of the whole bridge because a four hinged system will no longer function under lateral soil pressure after the destruction of struts.

The stream is normally a calm shallow watercourse and does not pose any threat to the road and the bridge (Fig. 4). But judging from the destroyed sloping wings we can assume that during short-term autumn or spring floods channel processes can be quite intense causing the erosion of the riverbed and banks directly near the inlet and outlet openings of the bridge, as well as under the bridge. This can lead to erosion of the embankment of the bottom under the bridge, uncovering the hidden struts 6, their poor condition or even partial destruction.

Therefore, a new spacing slab 11 was later concreted instead of them. Its sole is located on the restored layer of the new boulder-gravel-spall embankment, and the slab itself became the new bottom of the stream within the bridge. Moreover, this bottom was located above the mark of the typical year-round low water level (LWL). In addition, the outer part of the slab from the bridge entrance within the sloping wing and gabion is concreted with a reverse slope (against the current of the stream). So at normal service water level close to LWL, water does not flow from above the plate (streambed under the bridge is dry) (Fig. 1). However, it filters and flows under plate 12, probably through the remnants of waterworn embankment of the old streambed 9. Finding ways to flow in the ground is a natural property of water. But under further long-term operation of the reconstructed bridge, this phenomenon is unacceptable because sooner or later it can lead to a new uncontrolled erosion of the base under the slab and its subsequent destruction. Therefore, the reconstruction of the bridge should include adjusting the streambed and reinforcing from erosion both the banks of the stream and the slope of the embankment.

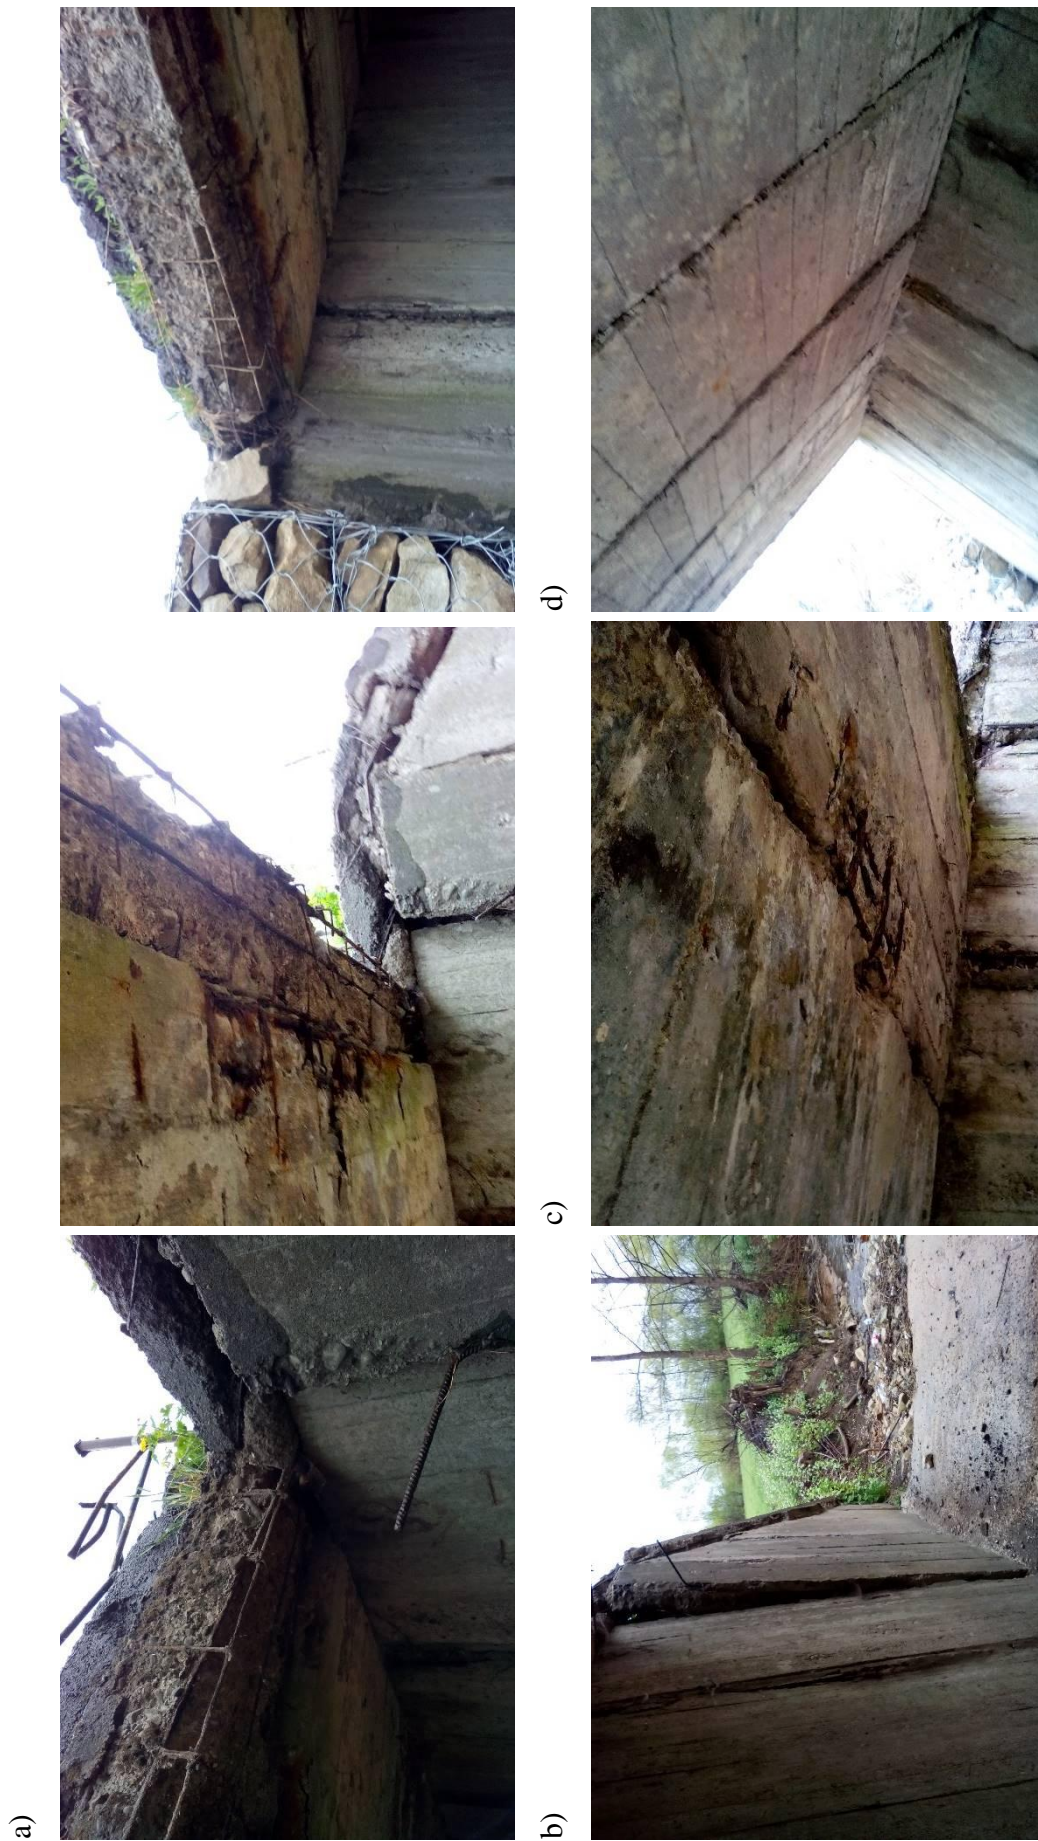
Fig. 3. Typical defects of reinforced concrete structures of the bridge:

- peeling of the concrete protective layer on large areas on virtually unprotected outer surfaces of both monolithic end slabs with the opening and intense corrosion of the working reinforcement with a reduction of its area up to 20% and even rupture of some clamps (Fig. 3, a). The inner layers of concrete of these slabs also have obvious signs of corrosion damage, e.g., cellular loose structure, cracks, which are characteristic signs of concrete casting of poor quality. Because of such damage, these slabs are considered as non-repairable and must be removed. New elements introduced into the span structure during reconstruction can replace their impact on the load-bearing capacity of the span structure. Precast concrete intermediate slabs have no significant defects (Fig. 3, d) and can be used for further operation after the reconstruction of the bridge;

- complete destruction of two straight sloping wings as the result of local erosion of the base (bottom of the stream) under the foundations that are not deep enough. The destruction occurred probably in the parts of the stream bottom with the greatest impact of flood waters. Gabions were collected on the site of the destroyed sloping wings to hold the embankment slopes (Fig. 1, 2). As they perform their protective functions perfectly, they can be left for further use.

One of the two currently available undamaged sloping wings is slightly deviated on the top near the expansion joint which separates it from the sustaining wall (Fig. 3, b). When reconstructing the bridge, this sloping wing must be additionally fixed to the new repair elements and thus prevent its further tilting. Front side slab elements of buttress do not have significant defects and can be used in the future after the bridge reconstruction (Fig. 3, d).

There are other operational defects that need to be eliminated during the reconstruction of the bridge. Thus, poor condition of waterproofing is evidenced by traces of leaching of concrete in the form of white flaky coating on the lower surface of the slab structure (Fig. 3, c). It is the most characteristic sign of water filtration, in particular in longitudinal seams between prefabricated reinforced concrete slabs. Some rods of transverse reinforcement of buttress slabs and span structure (Fig. 3, c) are uncovered because of insufficient protective layer of concrete, which leads to surface corrosion of this reinforcement (Fig. 3, c).

a – destruction of monolithic end slabs of span structure; b – tilting the sloping wing; c – sections of peeling of a protective layer and opening of reinforcement of prefabricated slabs of span structure; d – poor quality of monolithic longitudinal seams between the slabs and satisfactory condition of the open surface of the slabs

Some defects appeared during the manufacture of slabs, their transportation to the site and during construction and installation work: spalling of concrete, surface cavities, pinholes, fins, insufficient density of concrete, etc. To ensure the durability of the reconstructed bridge, these defects must be eliminated. All uncovered concrete surfaces of the span structure and buttresses must be protected from the aggressive action of the environment and possible corrosion during further operation with modern high quality materials.

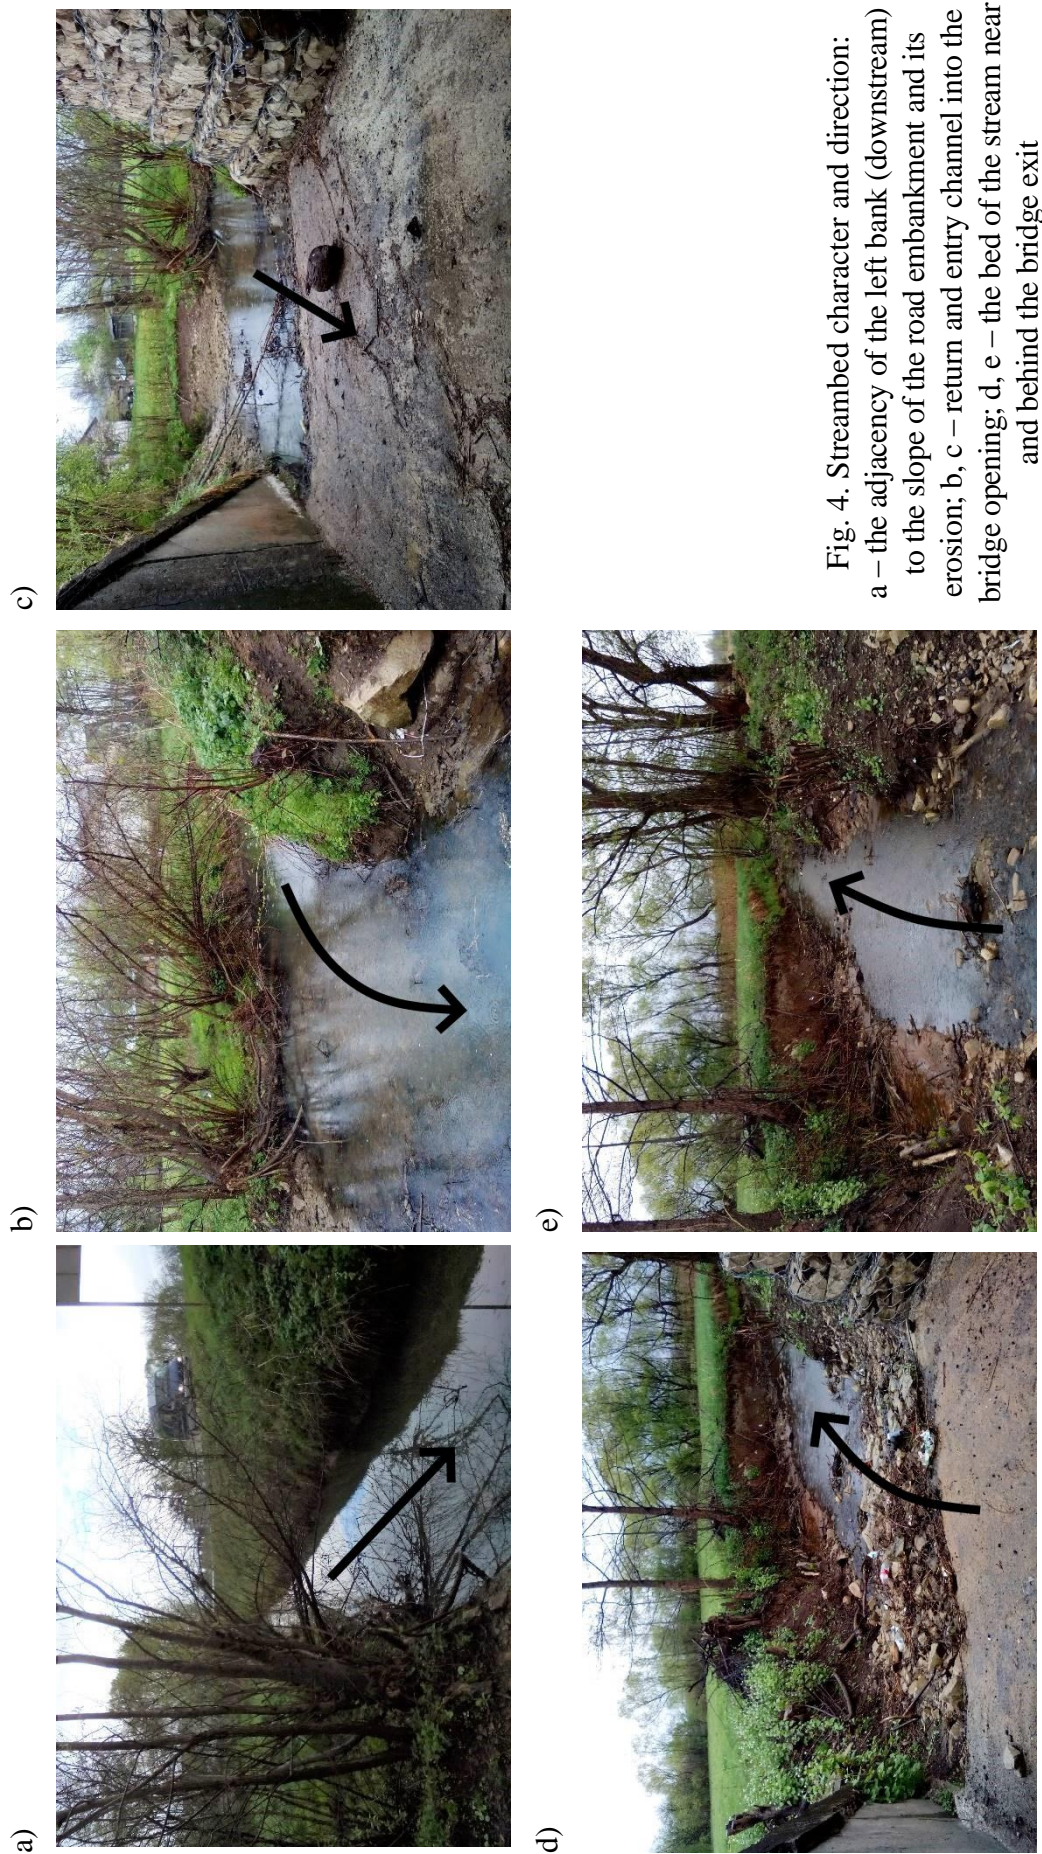
Fig. 4. Streambed character and direction:  
a – the adjacency of the left bank (downstream)  
to the slope of the road embankment and its  
erosion; b, c – return and entry channel into the  
bridge opening; d, e – the bed of the stream near  
and behind the bridge exit

The stream belongs to the typical piedmont permanent small watercourses (Fig. 4). Normally, it is characterized by a low-water level (LWL), the depth of which does not exceed 30-50 cm, with a channel width of up to 2.5-3.0 m.

The riverbed is cluttered with the remains of bushes, trees and flow of solid matter. The shores are low, flat, and steep in places after erosion (Fig. 4, c, d, e). At the approach to the bridge, its channel is almost parallel to the road, and the left bank (downstream) is adjacent to the slope of the road embankment (Fig. 4, a). Along the entire length of this area to the bridge entrance, its left bank together with the lower part of the embankment slope is significantly eroded to a total depth of 1.2-1.5 m (Fig. 2, c, d; Fig. 4, a). The process of erosion is not stabilized and occasionally continues. So, this part of the left bank of the stream and the adjacent slope of the embankment needs protection from further erosion.

The streambed turns sharply directly at the bridge entrance (downstream) (Fig. 4, b, c) and crosses the axis of the road almost at right angles (Fig. 2, a; Fig. 4, a). In terms of hydrology, the bridge is located in this unfavourable area. The width of the bridge opening coincides with the width of the stream bed and is 4 m (Fig. 2, a). A sharp turn of the riverbed creates extremely unfavourable conditions for the flow of flood waters and is ideal for erosion of both the riverbed and the banks of the stream. These processes are intense at the turns of the stream, as the curved channel significantly affects the distribution of velocities in the flow. The transverse and longitudinal flows of water that occur at the turns have a helical character. Jets that run into the concave shore go down, wash away the shore and bottom, transferring the erosion products to the opposite shore where they are deposited in the form of sediments [1]. Such nature of the channel process (channel deformations) under the action of flowing water causes destruction of the straight sloping wing of the bridge, located on the inner turn of the channel with the smallest turning radius, as a result of washing the base of shallow foundation.

To reduce the speed of flood flow in front of the bridge entrance, it is planned to create an extended zone of water intake when the channel under the bridge turns and the bottom of the channel in this zone rises to marks higher than the current mark of the top slab. The bottom of the streambed in this area also should be reinforced with a concrete slab 15-20 cm thick on a compacted boulder-gravel base (Fig. 6).

The manual [1] recommends providing strengthening structures such as blankets of large natural stones which are simple to use in the process of construction and further operation. This will help reinforce and protect the banks of the stream and the slope of the embankment of the earthworks approaches in the zone of erosion. Under these specific conditions, if the fractional composition of the rock is observed, the stone blankets are able to ensure the strength and resistance to the destructive effects of flood waters, as well as durability and efficiency.

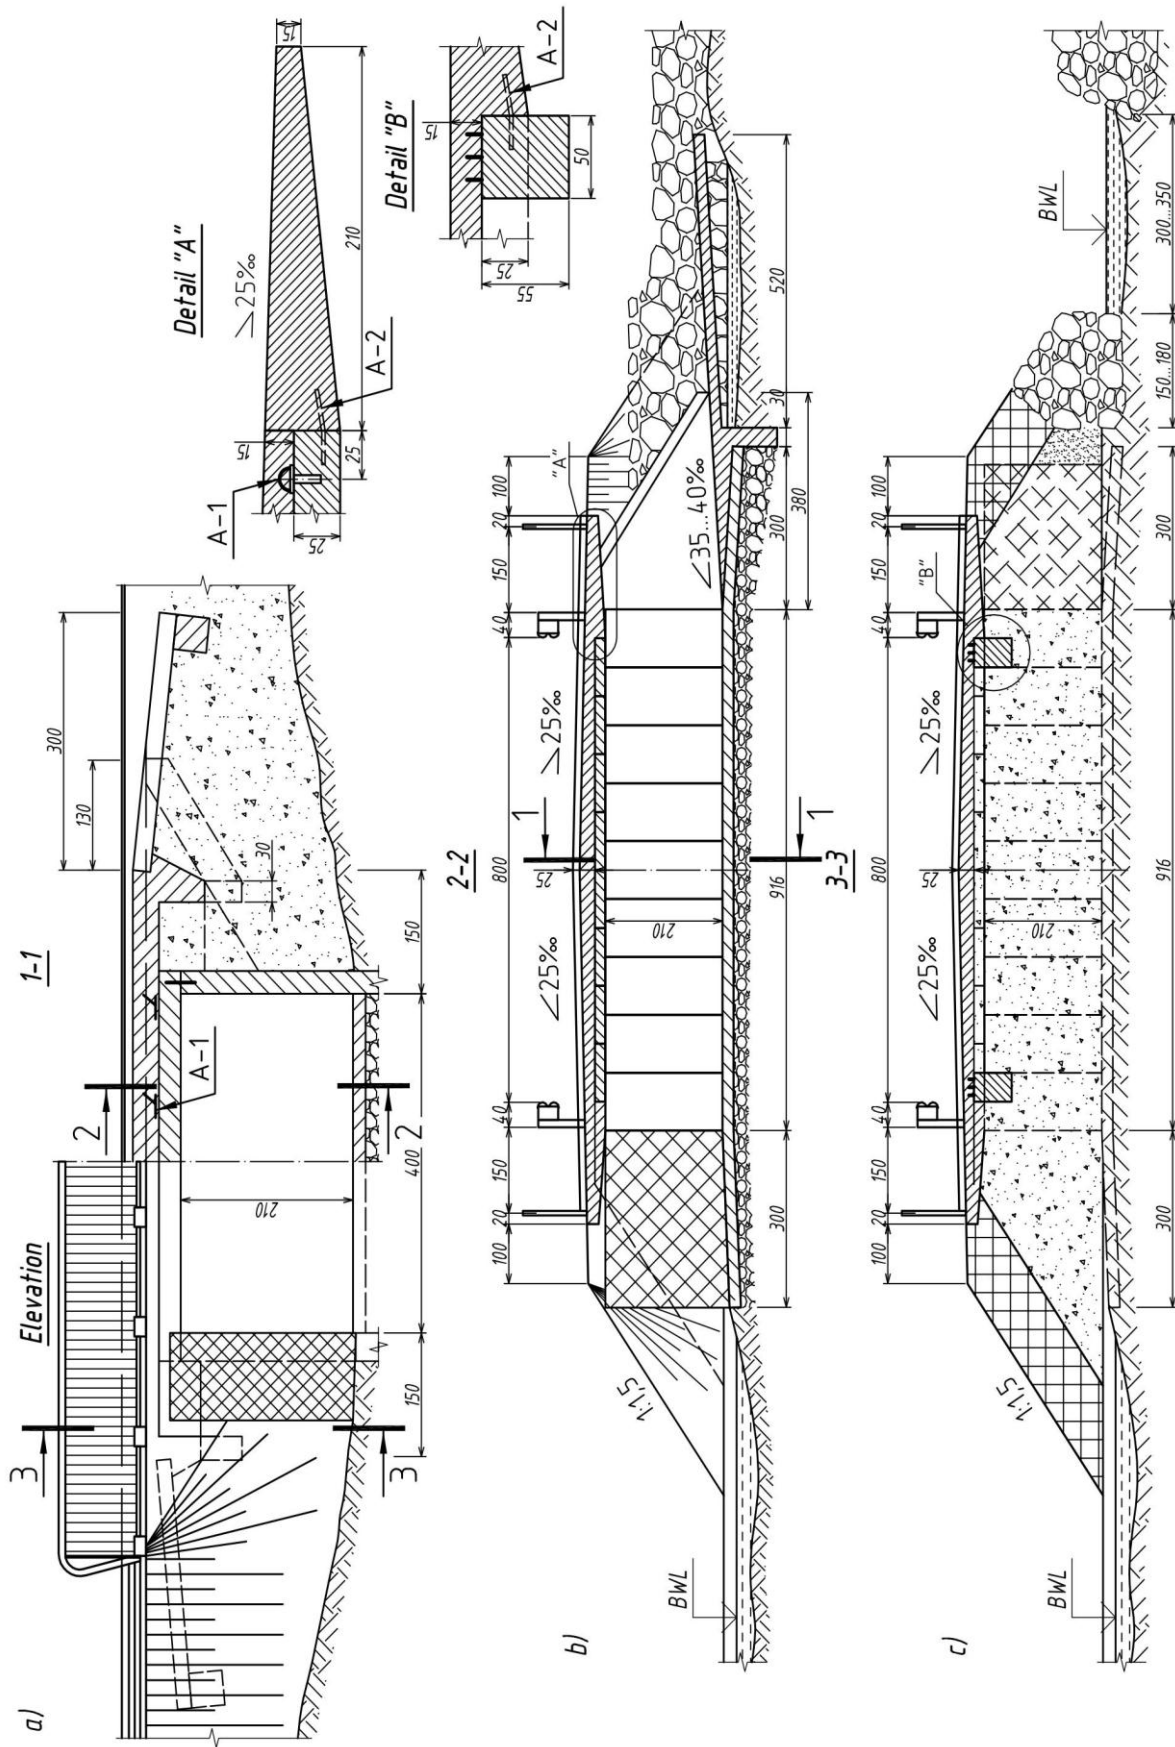
Fig. 5. General view of the bridge after reconstruction

The present span structure is widened from the size G-7.6 m without sidewalks to the new size G-8 m with sidewalks of 1.5 m at both sides, as well as protective barrier and railings according to the requirements of Building Code DBN B.2.3-14: 2006 and DBN B 1.3-22:2009.

In order to expand the span structure, Research Laboratory GNDL-88 of Lviv Polytechnic National University developed the design of a monolithic reinforced concrete cover slab with cantilever suspensions. These slabs and the existing ones were secured with special anchors [12] to ensure their joint work in the widened span structure (Fig. 5). In this case, the existing monolithic non-repairable end reinforced concrete slabs, 50 cm wide, are removed. The cantilever section of the cover slabs is adjacent directly to the open side surface of the prefabricated end slab, thus, protecting it. Rod anchors A-2 (part "B") also join it.

Cover slab is arranged on top of the existing ones. When necessary, it can be used to reinforce these slabs by lengthening the cross section from above, i.e. jointing the cover slab with the existing ones with loop anchors [12]. This ensures their joint work as part of the extended span structure (Fig. 5, part "A").

The reinforced concrete cover slab is lengthened by 1.5 m. This helps buttress piers to reduce the impact of the active horizontal soil pressure from the vertical temporary load located on the shifting prism. Transverse ribs are arranged at its ends to support the approach slabs. Thus, the vertical temporary load from these end sections of the cover slab as well as from the approach slabs is practically not transmitted directly to the soil of the shifting prism, i.e. the sustaining walls are unloaded from this part of the lateral soil pressure. This reduces bending moments in the sustaining wall like beams on two supports, i.e. it serves as reinforcement of the sustaining walls.
