**ASSESSMENT OF CARRYING CAPACITY OF THE ROUND IN PLAN REINFORCED CONCRETE FOUNDATION FOR THE SILO**<sup>1</sup>**Vybranets Yu.**, Ph.D,

The purpose of the work is to determine the technical condition of the building structures of the silo and the results of calculations performed in the PC Lira, to offer options for strengthening the foundation on a specific example.

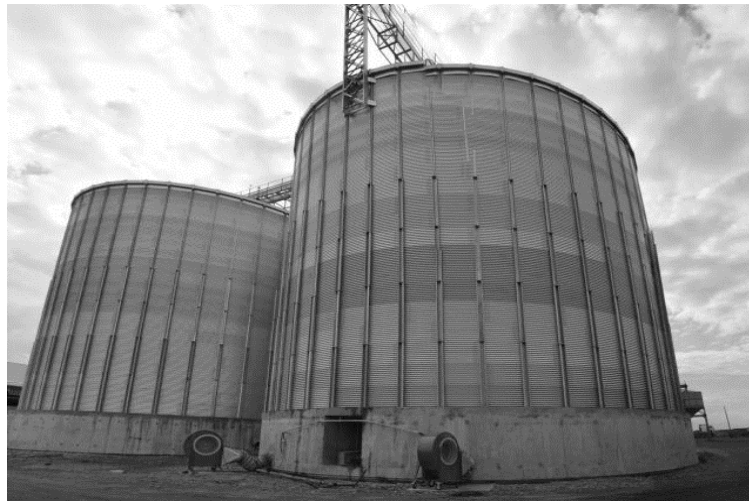
Fig. 1. General view of buildings

**Research results.** According to the structural scheme, the metal silo with monolithic reinforced concrete foundations. Next to it is another silo with similar dimensions and design (Fig. 1). To the south are two smaller silos.

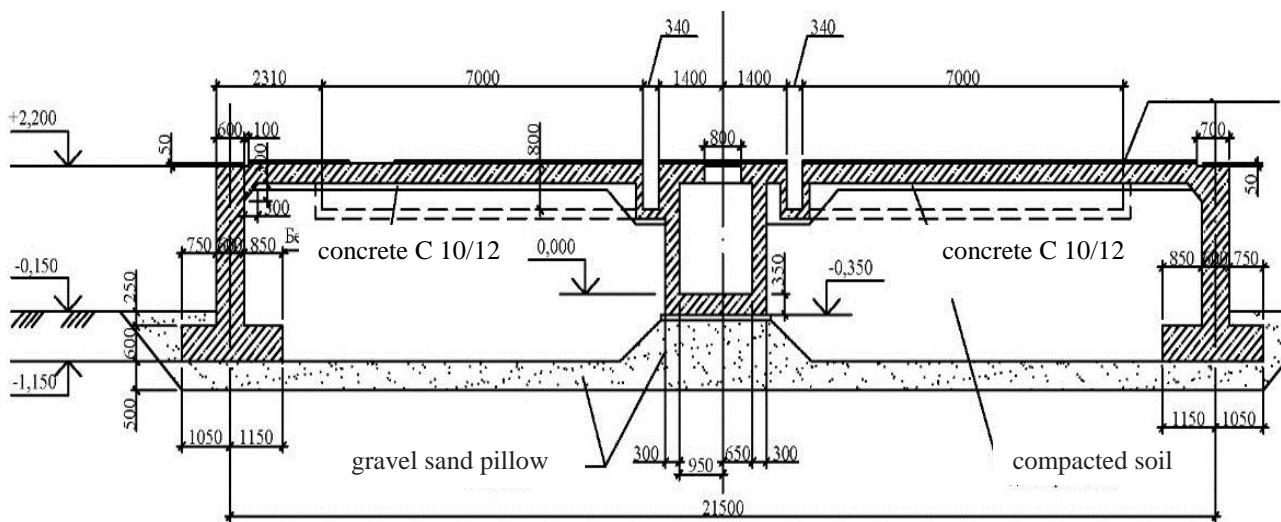
Fig. 2. Scheme of the foundation

According to the project, the foundation for the silo is monolithic reinforced concrete. The footing according to the project is shifted relative to the axis by 1050 and 1150 mm, respectively, from and to the center of the foundation. Therefore, the inner diameter of the footing is 19200 mm, the outer diameter – 23600 mm. The height of the foundation walls from the upper face of the footing to the lower face of the bottom of the silo is 2400 mm (Fig. 2).

The transitional gallery of the foundation is monolithic reinforced concrete. Its walls are 300 mm thick and 1800 mm high. Footing according to the project 350 mm thick. The bottom of the silo between the walls of the foundation is a monolithic reinforced concrete slab with a thickness of 350 mm, which rests along the contour of the foundation walls and compacted soil.

According to the structural scheme, the reinforced concrete foundation, footing and bottom of the silo are one solid element in the form of a frame structure.

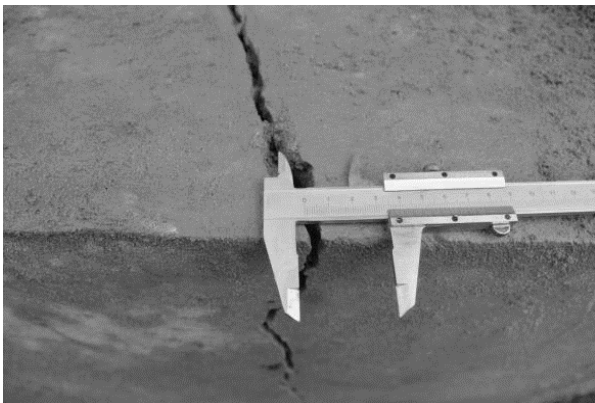
The main characteristics to be determined during the survey were: geometric dimensions of structures, subsidence of structures; width and length of crack opening, their location and nature; strength of concrete, location of reinforcement. A visual inspection of the aboveground part of the foundations revealed a number of cracks. The main cracks were located on the axis 2...3 between the axes A...B and on the axis 2...3 between the axes Б...B (Fig. 3) with a width of opening up to 4.4 mm. Cracks in the walls and the footing were also found in the gallery along the axis 2 between the axes A...B (Fig. 4) with a width of opening up to 1.9 mm.

Fig. 3. The width of the opening of the crack of the foundation between the axes 2...3 along the axes A...B

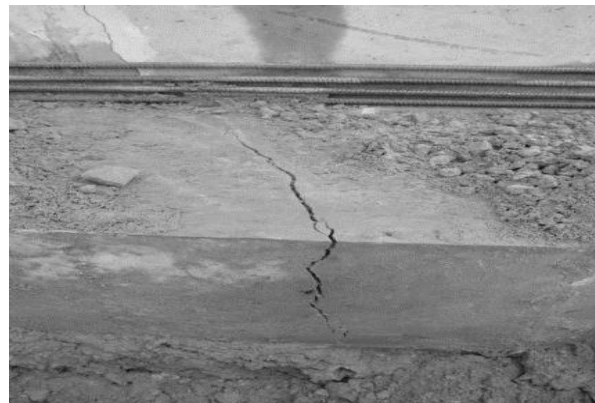
Fig. 4. The formation of a crack on the wall and the footing between the axes 2...3 along the axes A...B

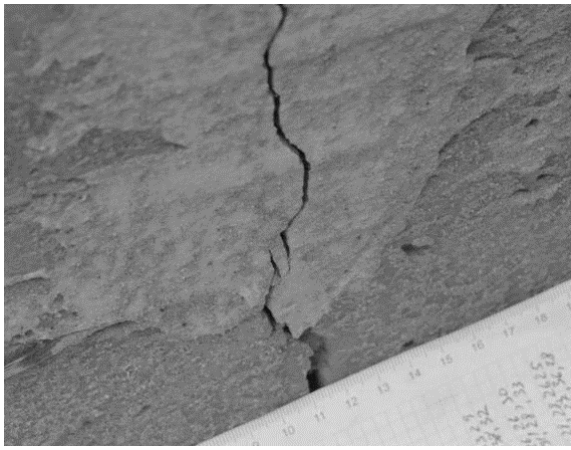
The underground part of the building was visually inspected by excavation. The pits were arranged in places of cracks. During the visual inspection, the development of cracks up to 6 mm wide was detected (Fig. 5). It was also found that the structure in the axes A...B between the axes 1...3 is arranged on the loose soil (Fig. 6, Fig. 7).

Fig. 5. Crack in the foundation between the axes 2...3 along the axes A...B

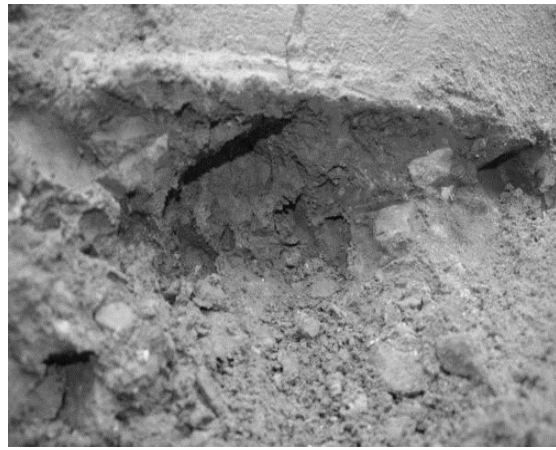
Fig. 6. Filling under the footing between the axes 1...3 along the axes A...B

When installing the pits, it was found that the footing is arranged at a depth of 560...600 mm from the ground, although the project specifies the installation of a footing to a depth of 1.0 m from the ground. This depth of laying the footing contradicts the regulatory design requirements, which take into account the installation of foundations at a depth of at least 700...800 mm for the region. However, it should be noted that the project provided for the installation of a strip foundation on a compacted gravel-sand mixture. As the results of the inspection [8] of the condition of the foundations showed, a limestone-sand mixed with the foundation soil was found under the footing. According to eyewitnesses, it is clear that the foundations were laid during the rainy season.

- the foundation is made of non-compliant materials and without compaction;
- the level of the footing laying does not meet the design requirements;
- the building is arranged on peat soils.

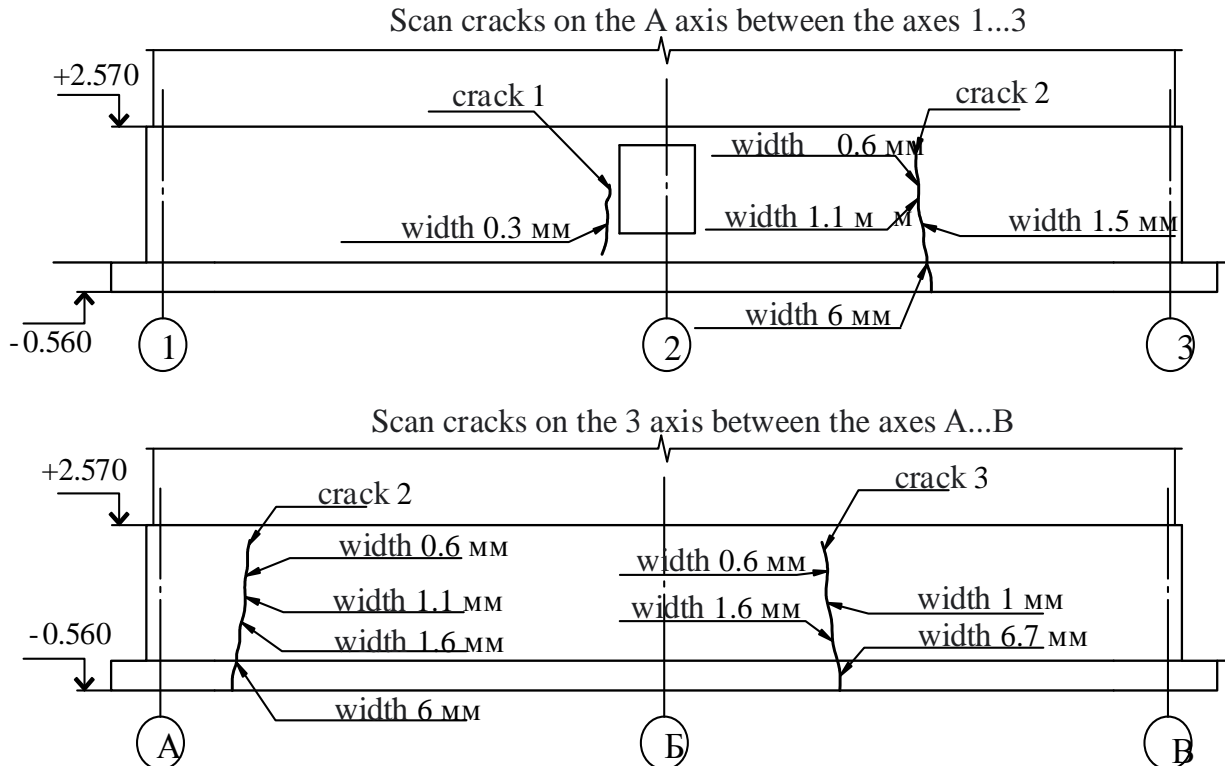
The process of crack development began during the operation of the facility, after 100% grain loading. The process of crack development run on now (Fig. 7).

Fig. 7. Scheme of crack development on the walls of the foundation

According to the above factors, the structure is arranged on peat soils and constantly settles unevenly. Uneven subsidence contributes to the development of cracks in the foundation slab.

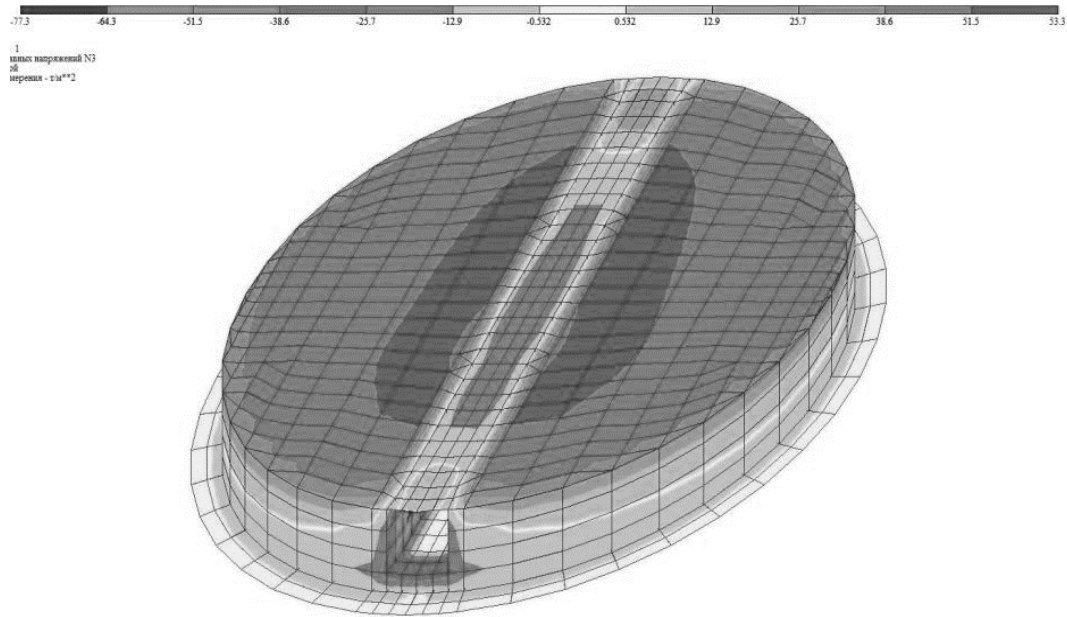
The results of the calculation on the LIRA PC (Fig. 8) showed an insufficient amount of reinforcement in the walls of the foundation on the action of longitudinal forces (1220...1380 kN), which contributes to the development of cracks in the walls of the foundation. Based even on the design requirements for the percentage of reinforcement, the cross-sectional area of the reinforcement in the foundation wall should be 45... 60 cm<sup>2</sup> with a cross-section of 60×167 cm. The development of cracks and their location is confirmed by verification calculations. Insufficient amount of reinforcement led to deformations in the foundation walls, as the existing class of concrete (C16/20) is not able to absorb such tensile forces. The location of the reinforcing bars in the grids of the footing is greater than the design requirements.

Fig. 8. Isopolies of main stresses

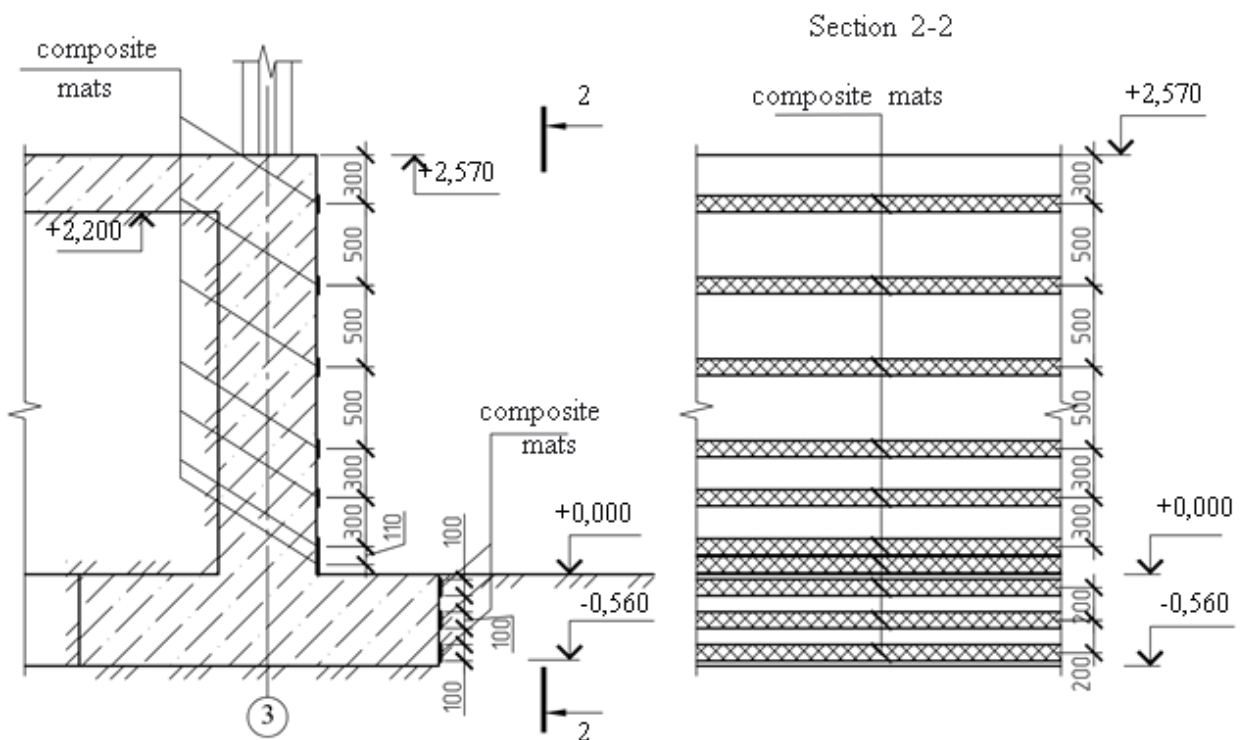
Fig. 9. Proposal to reinforce the damaged walls of the reinforced concrete foundation with composite tapes

For further safe operation of the structure, it is recommended to reinforce the walls of the foundations by gluing composite tapes (Fig. 9) and perform reinforcement of the foundations by piles (Fig. 10) according to the additional working design of the structure reinforcement.

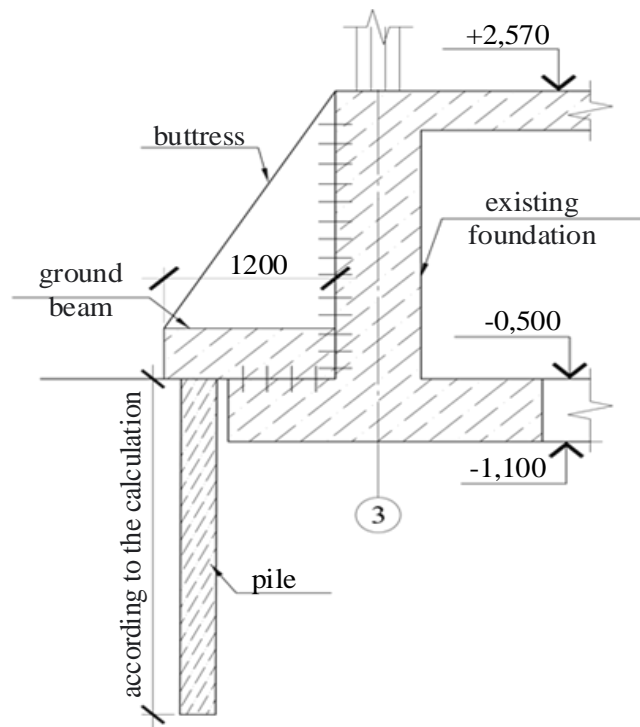
Fig. 10. Proposal to reinforce the damaged reinforced concrete foundation by means of piles
