SIMPLIFIED NON-DESTRUCTIVE METHOD FOR DETERMINING THE INTEGRITY OF HOLLOW-CORE SLABS

Abstract. The article presents the results of analysis of reinforced concrete hollow-core prestressed bench non-formwork molding floor slabs, manufactured using extrusion technology for defects formed as a result of a combination of a number of climatic effects during the construction of the building. The appearance of this kind of defects is quite common in construction practice. The issues of eliminating the causes of such defects, as well as strengthening damaged ceilings, are not the subject of this study.

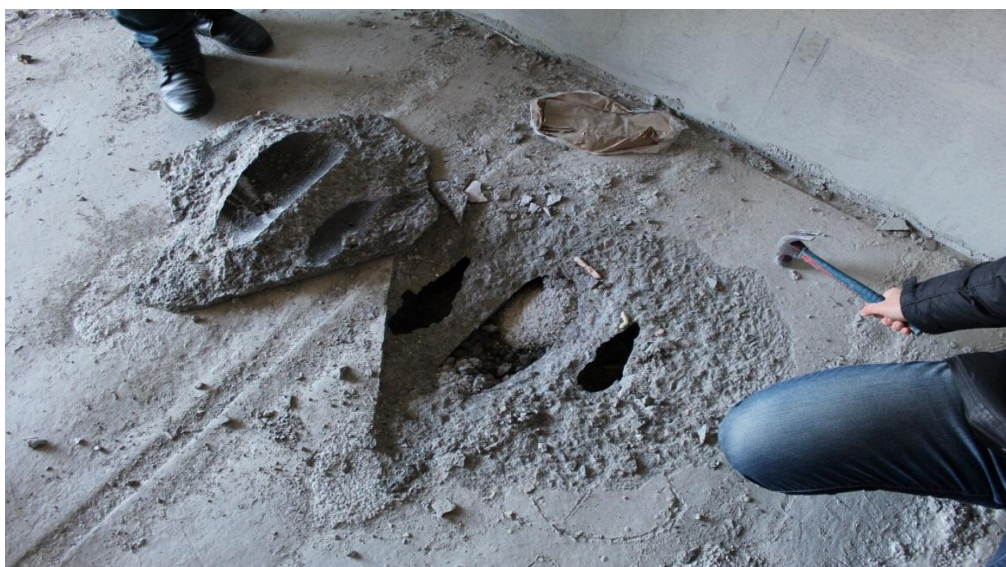
Fig. 1. Destruction in the upper part of the slab

But like all structures, prefabricated hollow slabs made by extrusion technology have their "Achilles heel". During construction, when the slabs are exposed to atmospheric influences, they absorb water from precipitation. With the combination of several climatic phenomena, this moisture accumulates in a significant amount inside the voids, turns into ice and causes structural defects. This absorbed water tends to accumulate inside the voids mainly between the monolithic areas or lifting loops. For typical slabs with a bend up in the middle of the span, water will tend to flow to the ends, and after freezing, chip off the shelves of slabs (there are a number of structural and technological measures to prevent such defects). Our group faced this problem when was analyzing the damage of floor slabs during the construction of the building (Fig. 1, Fig. 2).

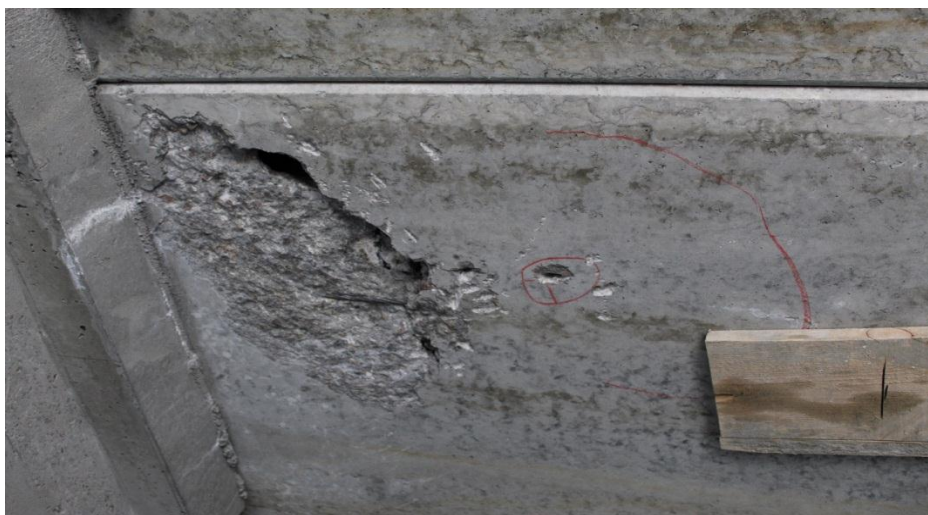
Fig. 2. Destruction in the lower part of the slab

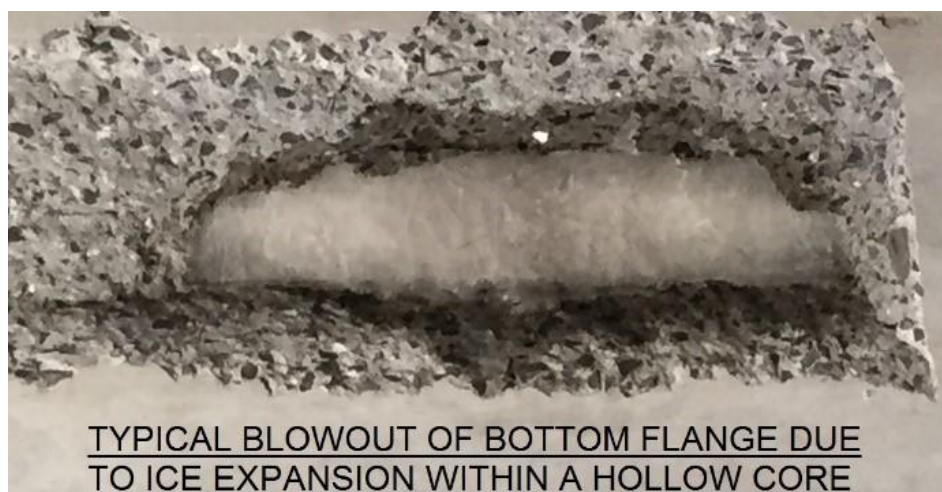
Fig. 3. Typical chipping of the lower shelf of the plate due to the expansion of the ice the USA, Maryland

Materials and methods of research. Such deformations of floor slabs are quite common around the world, where in the construction of buildings using such structures, locking can occur with subsequent freezing (Fig. 3) [4, 5].

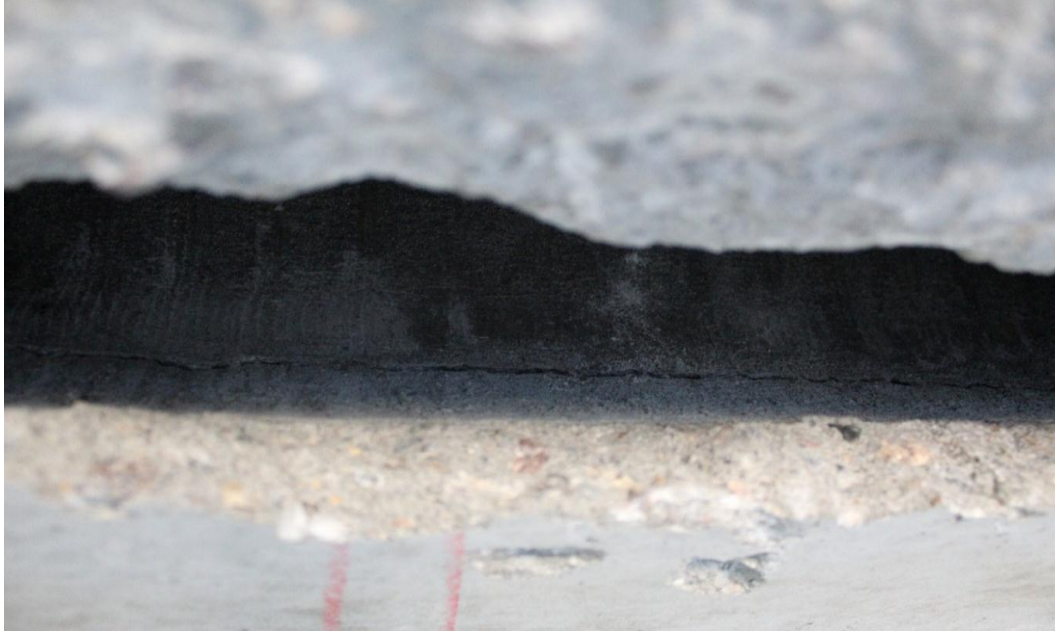
Fig. 4. A crack that appeared in the rib between the cavities

The problem determined in the course of the analysis of both foreign and own research indicates the probability of cracks not only in shelves, but also in the ribs of the floor slabs (Fig. 4), which cannot be detected visually at the input control at the construction site [6-10]. Such cracks can significantly affect the bearing capacity of the slabs. Therefore, a simplified technique is necessary that would allow to detect the presence of cracks in hollow slabs of floors.

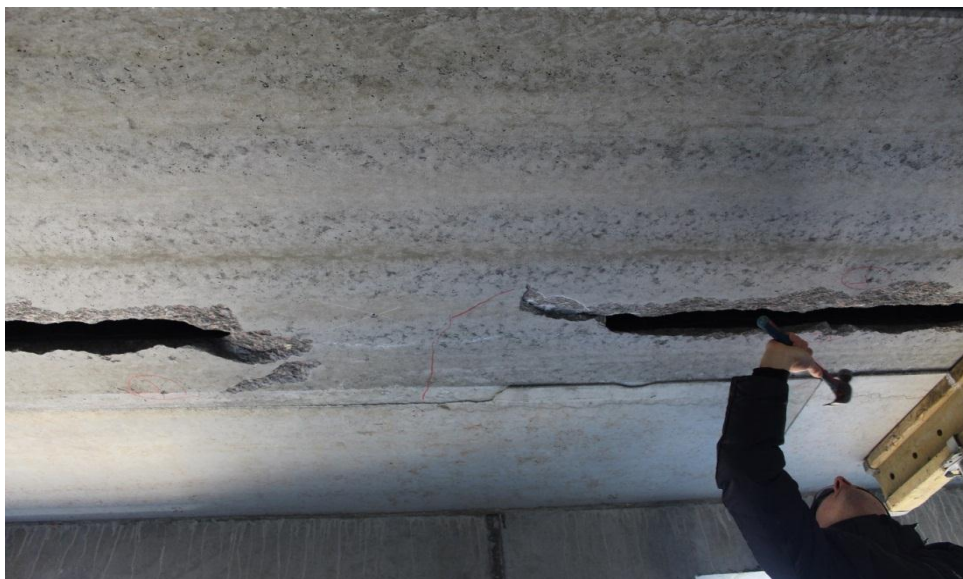
Fig. 5. Contours of damage after reflection of exfoliated surface layers

Results of the study. During the examination of a number of floor slabs, our group has been used a hammer, which in detecting damage in the form of detached layers beaten off damaged areas of concrete. After beating off the layers, the contours of damage became open for inspection (Fig. 5., red chalk circled a section of damaged concrete to be dismantled). The hammer was used to reflect the peeled concrete in the upper and lower parts of the slabs. During the beating off, the boundaries of the

damaged and intact fragment of the structure were easily determined due to the fact that the sound was significantly different: when hitting the damaged concrete, the sound was thud, and the sound was voiced on the intact concrete. In further studies and detection of damage of the ribs between the voids, a third – intermediate type of sound was identified, while the visual indications of the presence of damage were absent, both during the inspection of the lower surface and during the inspection of the upper surface, the hair cracks along the joints of the floor slabs were also absent.
