**STUDY OF THE LOAD-BEARING CAPACITY OF STRUCTURES OF LONG-TERM OPERATION OF THE FORMER "MODULE" PLANT IN UZHGOROD**

**Presentation of the main research material.** An inspection of the structures of a non-residential building of the former Modul plant after long-term operation was carried out to order from the building owner in accordance with Agreement No. 58-2023 dated June 06, 2023 by a team of leading experts of the private entrepreneur Karkhut I.I. The result was to determine the actual technical condition of the building's structures and develop recommendations for repairs to ensure further reliable operation after its repurposing.

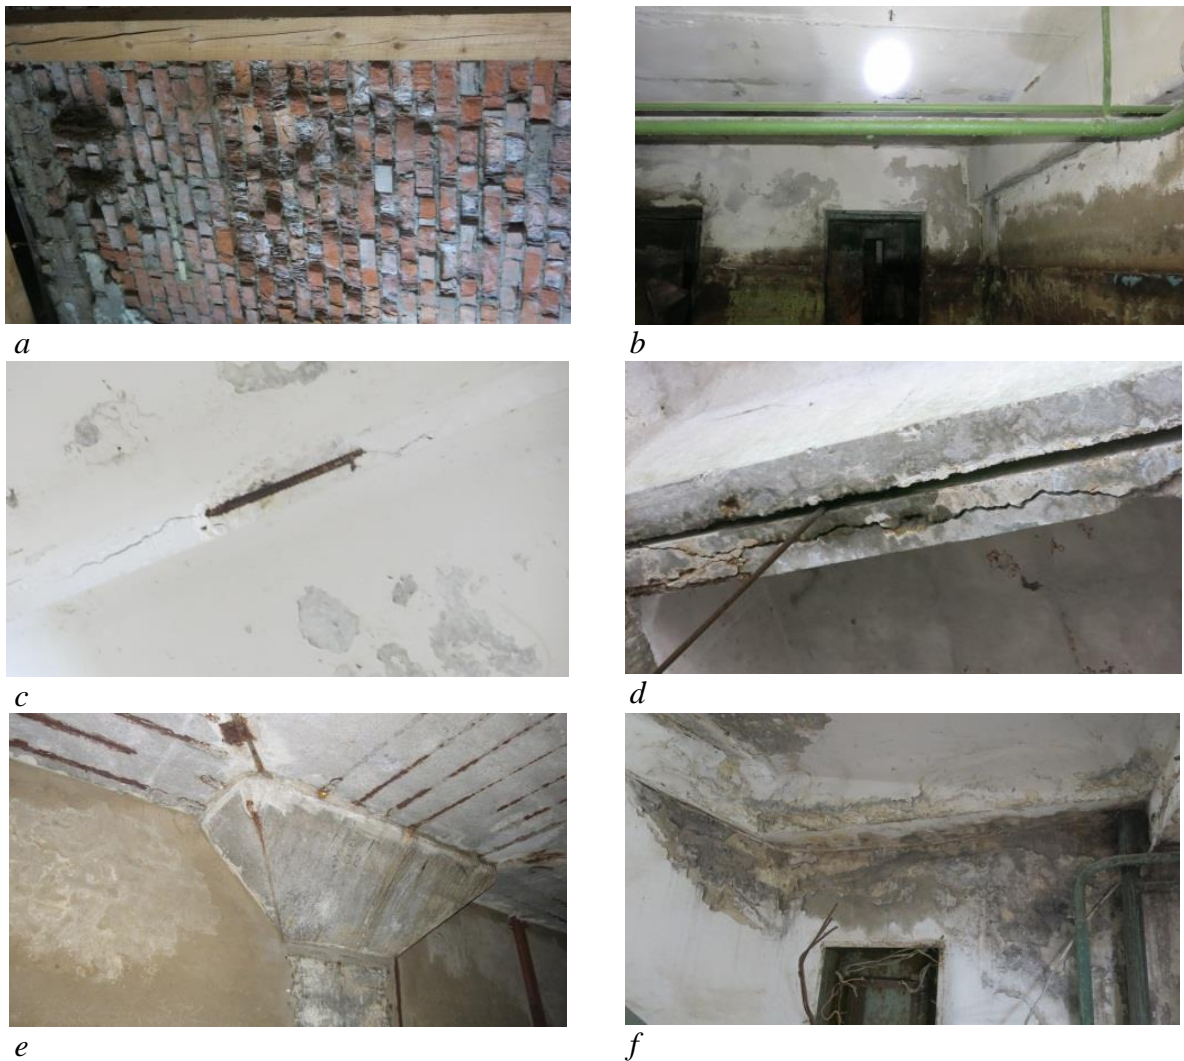
The defects found in the enclosing structures are as follows: leaks in the joints of sheets of profile flooring, leaks in junctions with walls and in ridges. Destruction of the brick walls of the staircases was detected to a depth of 30–40 mm due to periodic freezing (Fig. 1, a). Corrosion of metal structures of frames on the technical floor is insignificant (local) and uniform on the surface. The technical condition of the metal structures is satisfactory.

The overlap of the shelter is reinforced concrete monolithic ribbed. The main defects and damages detected during visual inspection are the following: cracks on the surface of the slab up to 0.3 mm wide (Fig. 1, b), carbonization of concrete to a depth of up to 15 mm and a decrease in the strength of concrete up to 15–20% (Fig. 1, b). Photographic recording of defects, damage and shortcomings of long-term operation is shown in Fig. 1 and in work [14]. It should be noted that the detected defects and deficiencies are located in separate areas of the floor slab and column capitals without a clearly defined system (Fig. 1, e). In our opinion, the main reason for their occurrence and development was prolonged flooding of the shelter.

Fig. 1. 1. Degradation of structures of buildings of the former Modul plant in Uzhgorod: *a* – destruction of the masonry walls of the staircase made of brickwork to a depth of 50 mm in Section 2 from periodic freezing and thawing; *b* – traces of flooding of the shelter to a height of 2 m in the basement of Section 1 (carbonization of concrete and reduction in concrete strength); *c* – cracks along the edge of the floor slab on the third floor of Section 2 (corrosion of the working reinforcement in the edge of the slab); *d* – cracks in the rib of the floor slab on the second floor of Section 2 (destruction of the protective layer of concrete, carbonization of concrete, peeling of the protective layer, corrosion of the reinforcement of the floor slab and capital); *f* – periodic flooding of the shelter in the basement of Section 2, resulting in the appearance of damage shown in Fig. 1 *a–f*

In the shelter under Sections 2 and 3, the main defects discovered during the inspection were the complete destruction of the equipment of engineering systems and stone brick partitions as a result of flooding (Fig. 1 and work [14]). The floor is prefabricated monolithic. The main structural defects detected during a visual inspection are the following: cracks in concrete walls and floor slabs with an opening width of mainly up to 0.25 mm, and in some places up to 0.35 mm (Fig. 1, *c, d, e*); penetration of moisture through cracks in structures.

Carbonization of the concrete of floor slabs, columns and capitals in the shelter, and peeling of the protective layer of concrete were revealed (Fig. 1, *c, d, e*). Corrosion of mounting and

working reinforcement was detected in the ribs of floor slabs and columns and capitals, corrosion of embedded parts (Fig. 1 *c, d, e*) and surface corrosion of concrete.

As a result of a visual inspection, damage and shortcomings of long-term operation were identified and localized, and their descriptions were made. All detected defects as of June 26, 2023 generally have a local effect on reducing the strength and rigidity of individual load-bearing structures and can be eliminated during repair work. The general technical condition of the 2nd and 3rd Sections of the building according to the classification tables [15] is satisfactory, taking into account the reduction in the level of loads during repurposing. Structures require ongoing repairs to eliminate detected defects and damage. It is recommended to eliminate detected defects and damage to load-bearing reinforced concrete structures using modern materials and technological solutions given in [16].
