### **BUILDING STRUCTURES**

## THE KNOWLEDGE OBTAINED FROM THE MAIN INSPECTIONS OF PEDESTRIAN BRIDGES IN PREŠOV

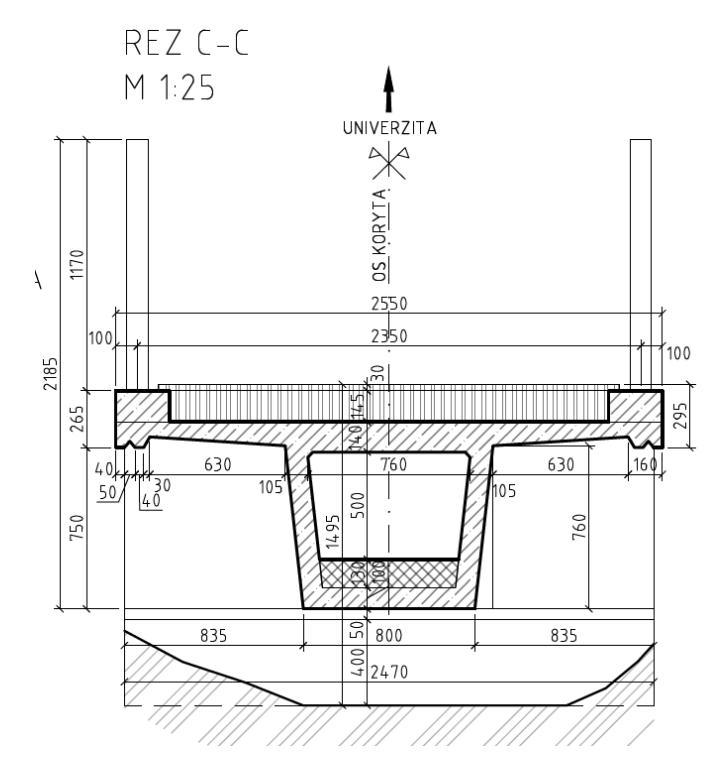
Fig. 1. Schematic cross-section of the structure

**Results of the study.** Assessment of defects of pedestrian bridges. Segmental pedestrian bridge next to the University of Prešov. The pedestrian bridge structure consists of concrete segments fastened together with prestressing tendons located in the chamber. The tendons near the bottom slab are covered with additional cement filling (Fig. 1).

On inspection of the bridge, a significant deflection was visible. This deflection was noticeable on the bottom slab and the bridge's handrail. After a more detailed inspection of the structure, it was discovered that the opening of joints at the contact of beam segments occurred (10 – 15mm) in the middle of the second span. This phenomenon indicates problems with prestressing reinforcement (Fig. 2). After removing the inspection holes in the area of the abutments, it was found that the filling mortar had completely deteriorated due to the very high humidity and freezing cycles.

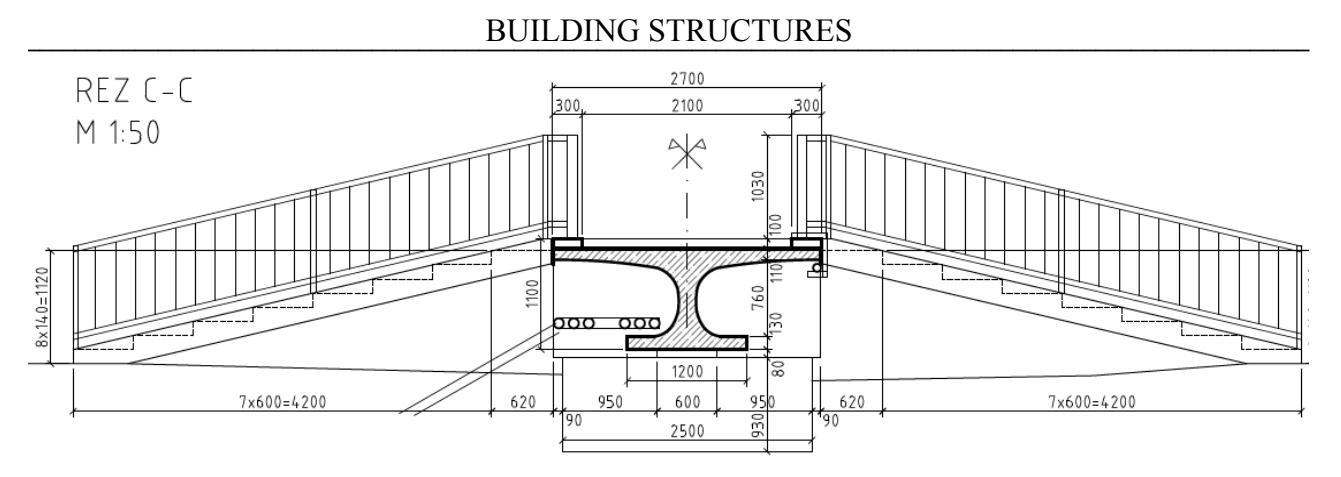
Fig. 5. Schematic cross-section by abutment

*Pedestrian bridge over the Torysa river on Mukačevska street.* The pedestrian bridge made of an atypical, prestressed concrete beam with a total length of 39.25 m and a height of 1.0 m indicates excessive cracks with a width of 2 mm at the working joints, approximately 3 m from the piers. The anchors of the prestressing reinforcement and the anchored prestressing cables are visible in the joints, insufficiently grouted and partially corroded (Fig. 5). However, the bridge slab does not show excessive deflections. The approach ramps with stairs have deteriorated significantly, and their reinforcement is massively corroded due to inadequate concrete cover, probably also due to manufacturing defects. The abutments show significant concrete deterioration and corrosion of the steel reinforcement due to leakage. The bearings on the abutments corrode. The bridge has been closed to the public due to non–grouted prestressing tendons and the disrepair of the access stairways.

Concrete samples taken from the ledges, under the asphalt and from the bottom slab did not confirm excessive chloride content in the concrete, probably due to the lower intensity of winter maintenance. Prestressing tendons corrode significantly slower, although they are not grouted with cement (Fig. 6). The low chloride contamination of the concrete creates good preconditions for the reconstruction and further functioning of the bridge. The bridge has already been reconstructed and reinforced with free-running external prestressing cables.
