## INVESTIGATION OF THE STRESS-STRAIN STATE OF BUILDING STRUCTURES DAMAGED BY EMERGENCY SITUATION

**Abstract.** The article investigates the stress-strain state of building structures damaged due to an emergency situation resulting from a missile strike on a building in Odesa. The study aimed to comprehensively analyze the technical condition of the damaged structure, evaluate the impact of the missile strike on bearing capacity and deformation behavior, and provide recommendations for restoration. The authors conducted detailed instrumental inspections utilizing non-destructive testing techniques, performed topographic and geodetic surveys to determine structural verticality, and carried out verification analyses using the "LIRA-SAPR" software. Significant damages to columns, floor slabs, and external walls were identified, creating a risk of progressive structural collapse. The structures were classified as being in an emergency state, with damage levels reaching up to 80%. The proposed restoration measures involve dismantling and reconstruction of damaged elements, reinforcement of load-bearing structures using metallic components, installation of temporary support systems, and

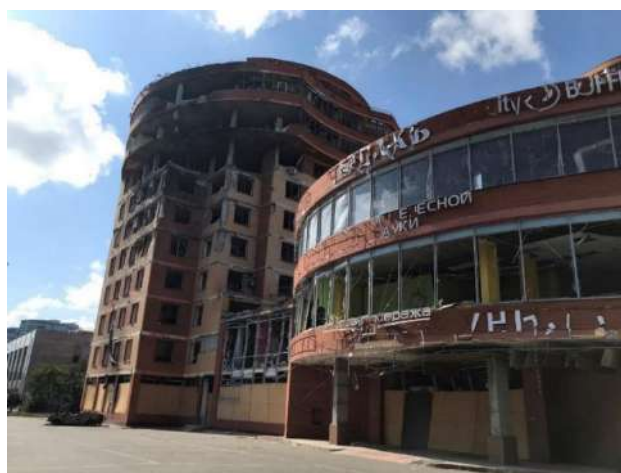
Fig. 1. General appearance of the facade of the building

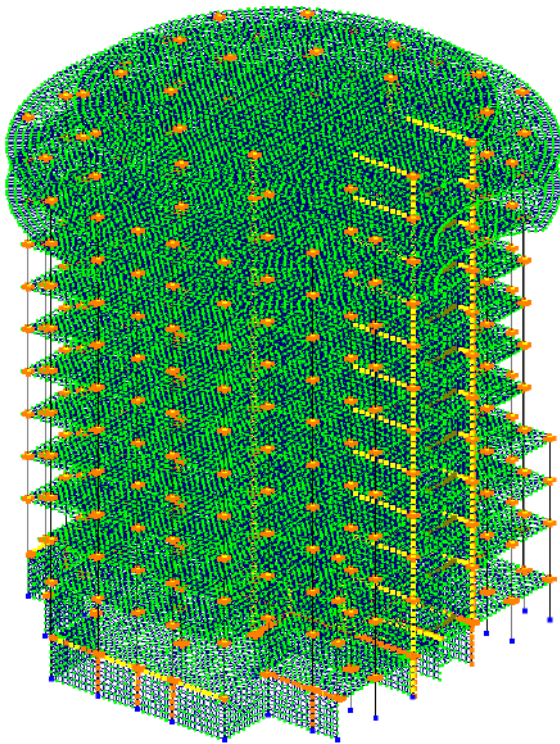
Fig. 6. General view of the settlement scheme

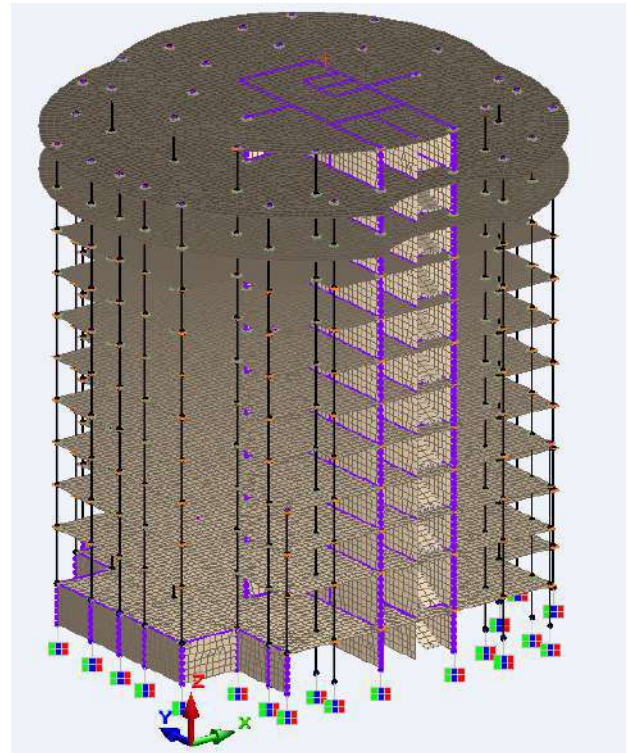
Fig. 7. General view of the settlement scheme

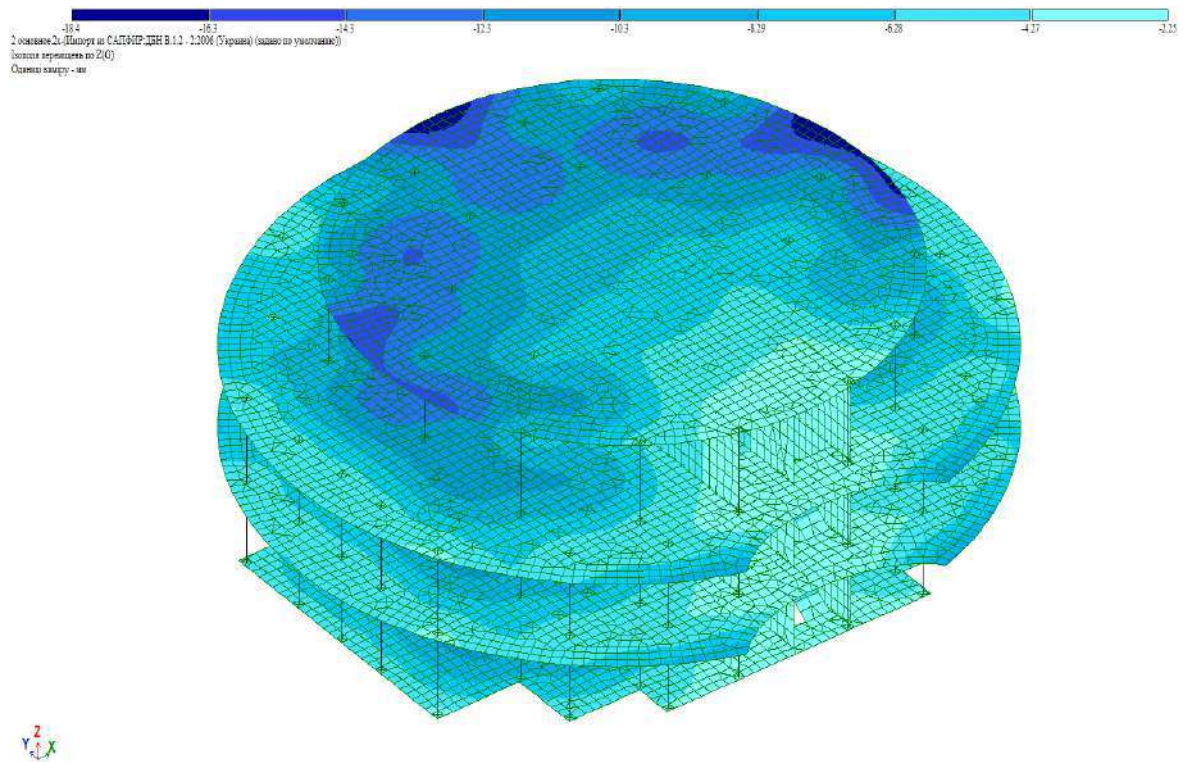
Fig. 8. Mosaic of movements (deflections) of nodes along the Z axis. Option №1.  
 A fragment of the design scheme of the load-bearing structures of the building without damage.

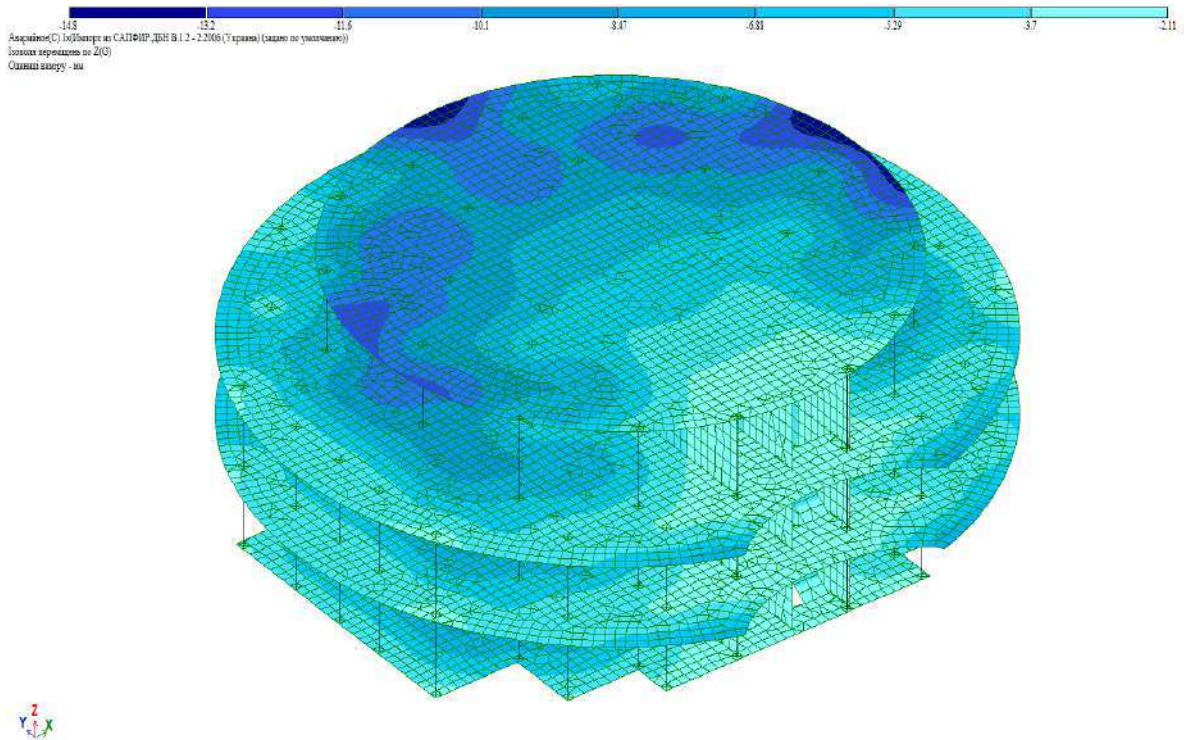
Fig. 10. Mosaic of movements (deflections) of nodes along the Z axis. Option №3.  
A fragment of the design scheme of the load-bearing structures of the building with reinforcement of the main load-bearing structures

13. According to the calculation results, it is recommended to frame the damaged columns with metal corners – 100×7 and metal plates – 6×50×100 mm and reinforce the floor slabs at the places of cracks, damages, and deformations.

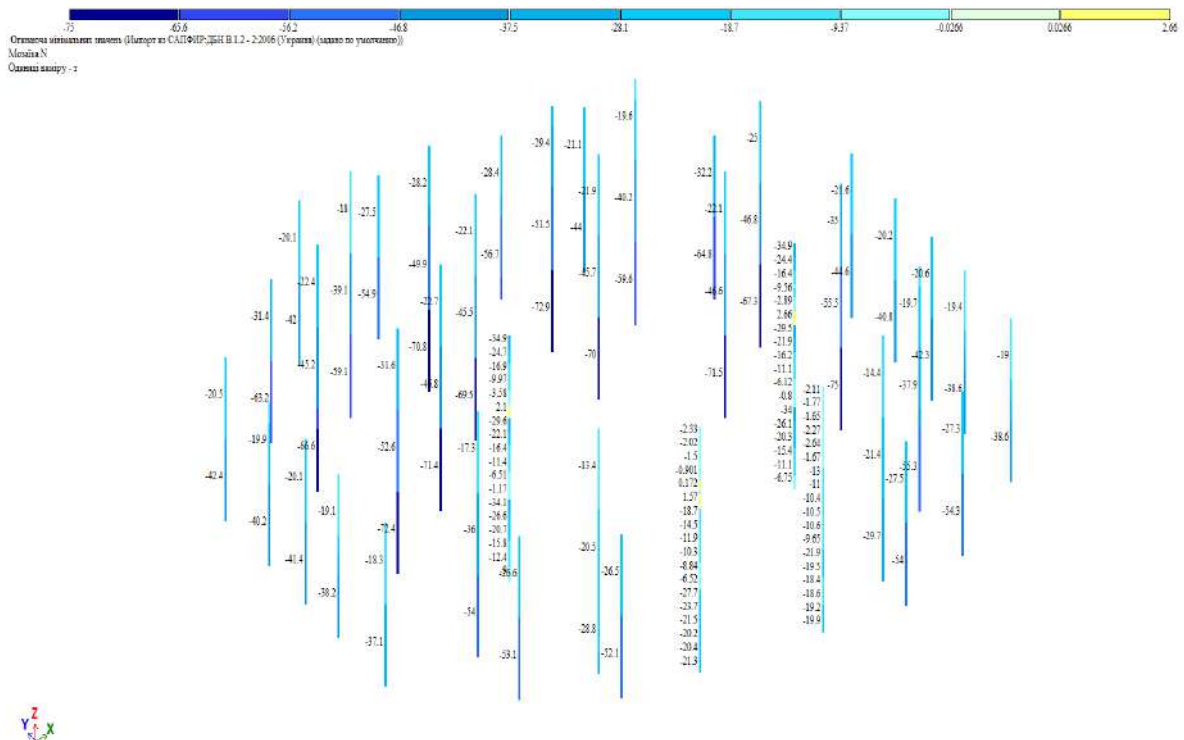
Fig. 11. Mosaic of internal longitudinal forces N. Option №1.  
A fragment of the design scheme of the load-bearing structures of the building without damage

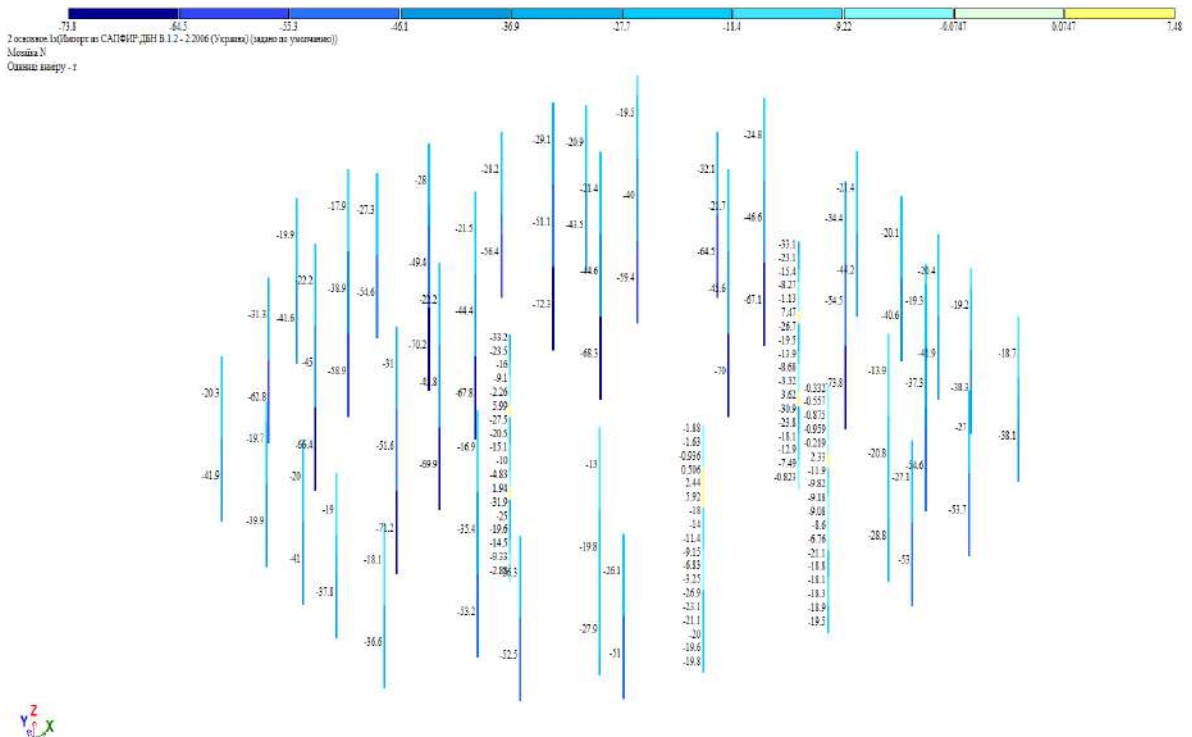
Fig. 13. Mosaic of internal longitudinal forces N. Option №3.

A fragment of the design scheme of the load-bearing structures of the building with reinforcement of the main load-bearing structures
